MEMORANDUM

State of Alaska
Department of Transportation & Public Facilities
Northern Region Preconstruction

SUBJECT: Dalton Highway MP 0 to 9
Realignment Project.
Preliminary Geotechnical
Investigation Memo
AKSAS 60911

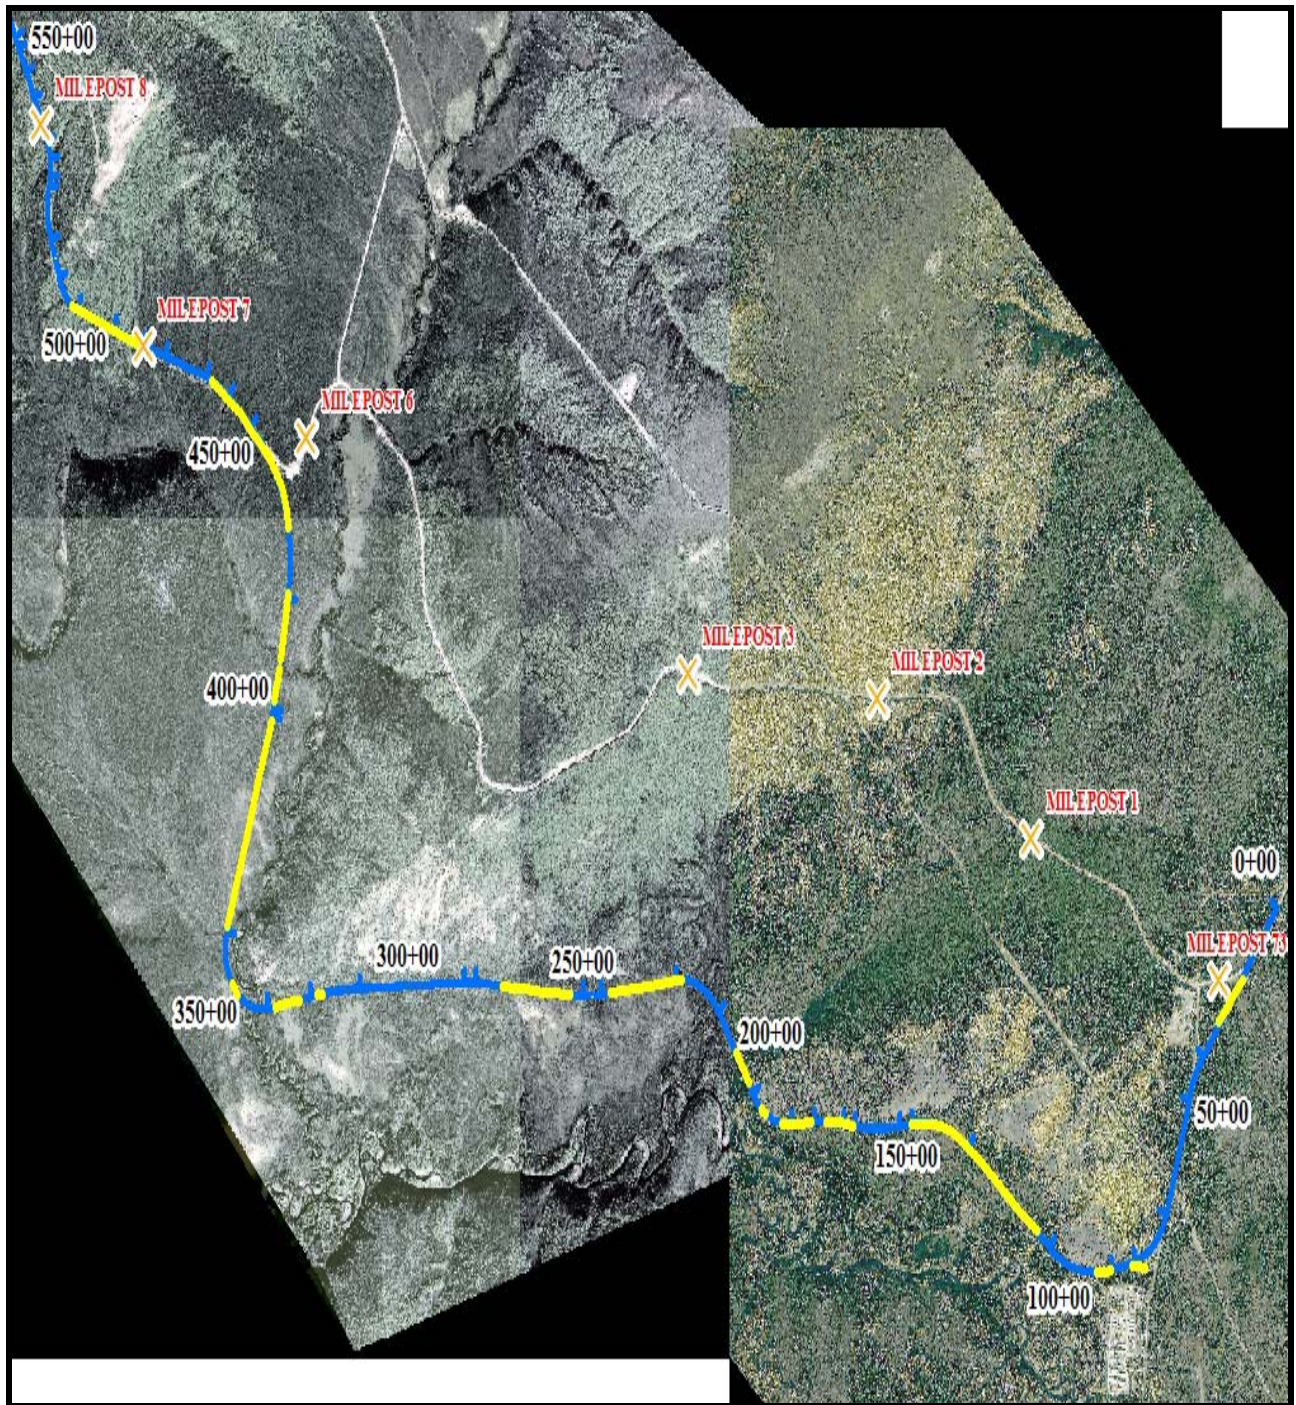
Figure 2: Dalton Highway Realignment Project MP 0 to 9. Proposed realignment and reconstruction, with yellow representing those areas with ice-rich silt greater than 8-feet thick. These areas represent approximately 42 percent of the project. Map is based on drilled test hole information only.

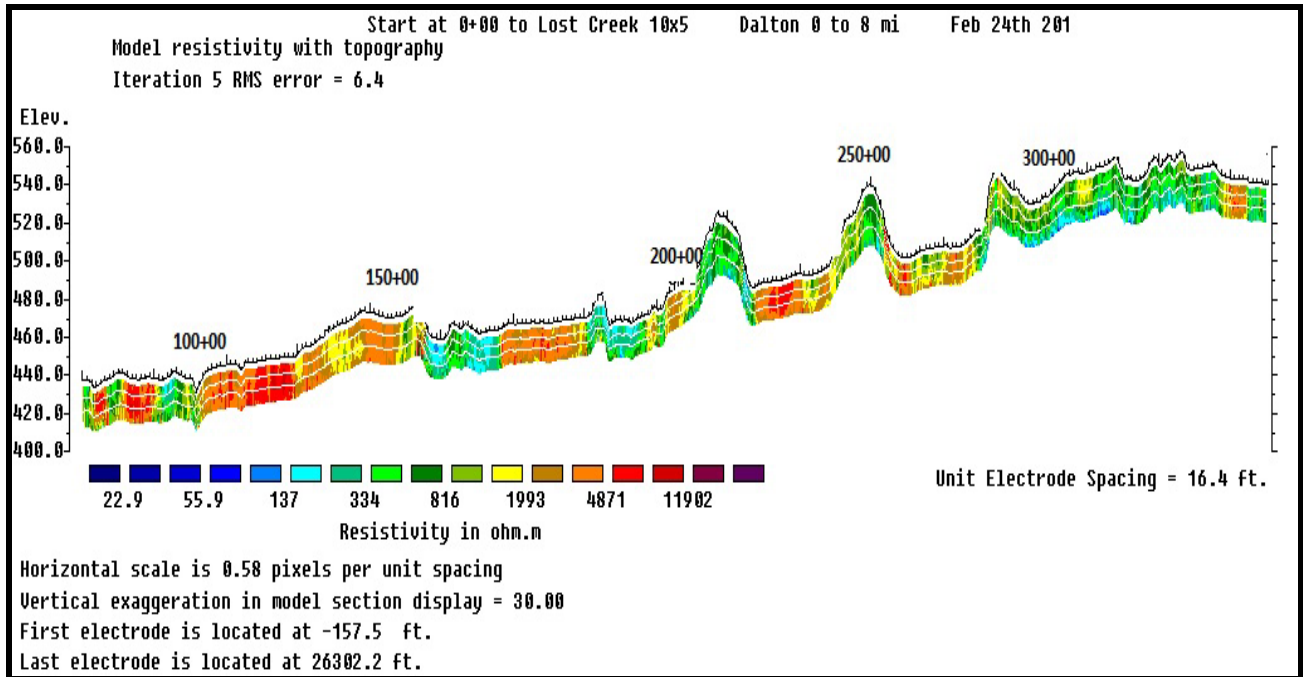
Figure 3: Dalton Highway Realignment Project MP 0 to 9. Ohm-Mapper resistivity survey results from Elliott Highway to Lost Creek (approximately Stations 76+00 to 340+00). Hot colors (orange and red) indicate ice-rich subsurface soils and cool colors (blue and green) indicate ice-poor subsurface soils in those areas indicated. Survey also indicates topography.

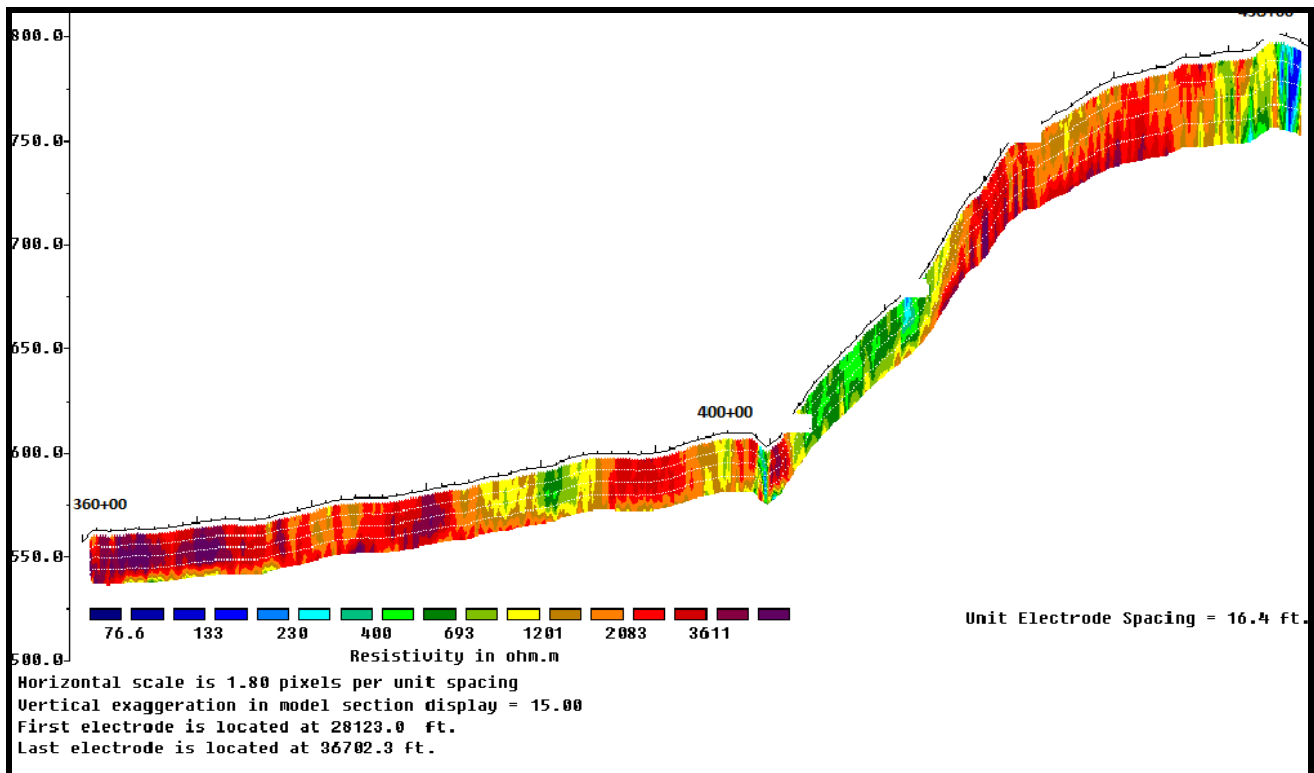
Figure 4: Dalton Highway Realignment Project MP 0 to 9. Ohm-Mapper resistivity survey results from near Lost Creek to Dalton Highway MP 6.2 (approximately Stations 360+00 to 450+00). Hot colors (orange and red) indicate ice-rich subsurface soils and cool colors (blue and green) indicate ice-poor soils in those areas. Survey also indicates topography.

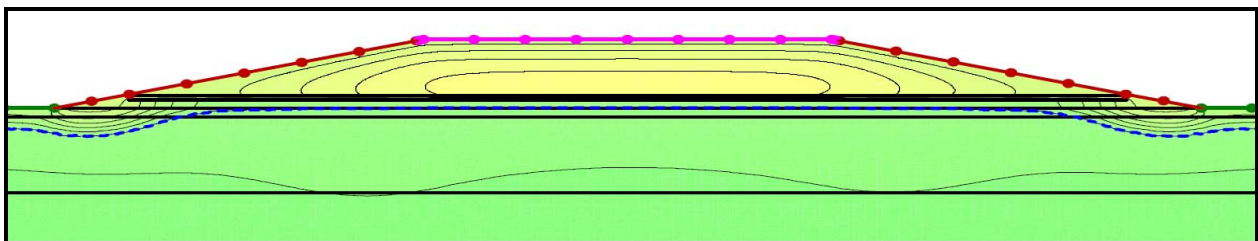
Figure 5: Eight foot embankment with 6-inches of insulation board under historic temperatures. Maximum depth of thaw occurs approximately during the last week in September. Dashed blue line is the 32 degrees Fahrenheit isotherm.

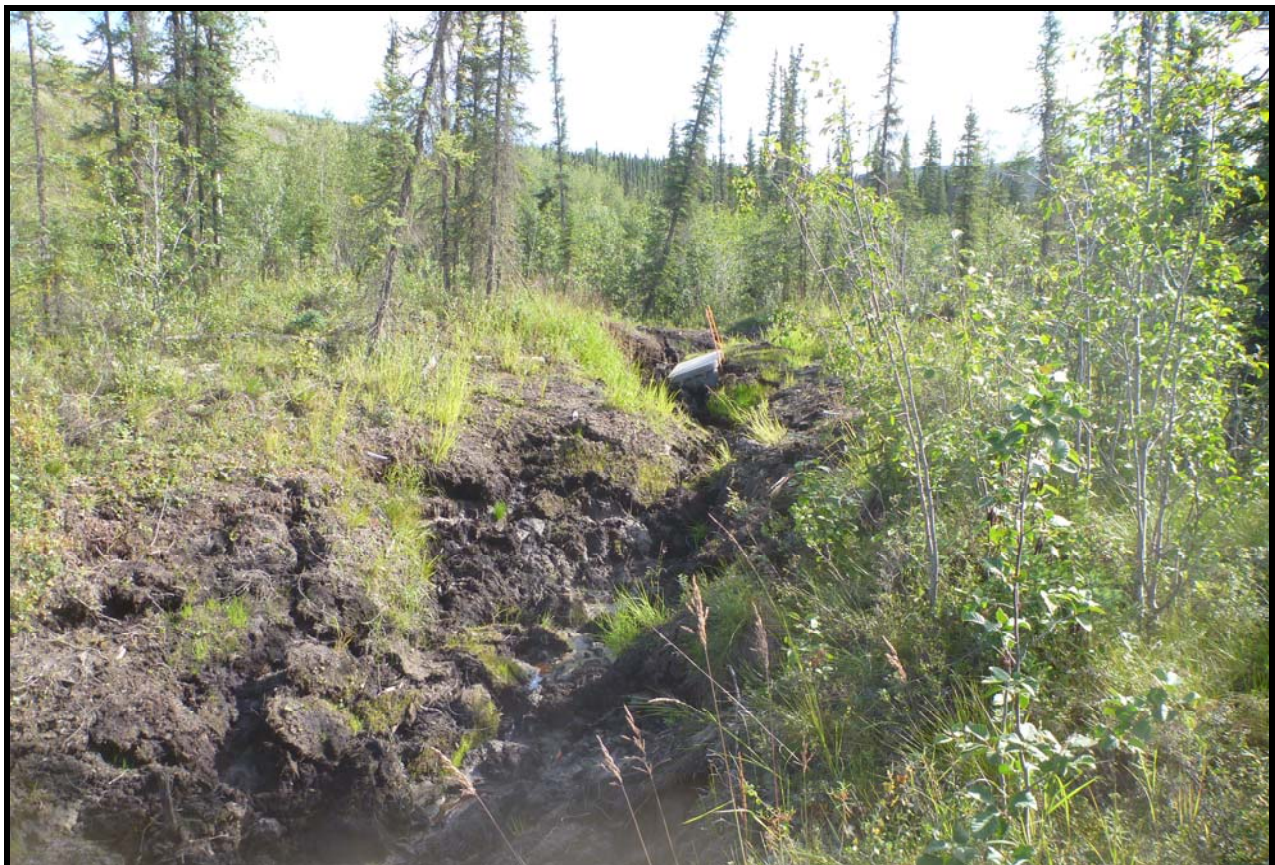
Figure 7: Existing utility easement near Rose Bud Creek and station 25+80. Photo is looking east with the Dalton Highway embankment to the left. The fiber optic excavation experienced approximately 3- to 4-feet of thaw settlement over a period of approximately two months in 2014.

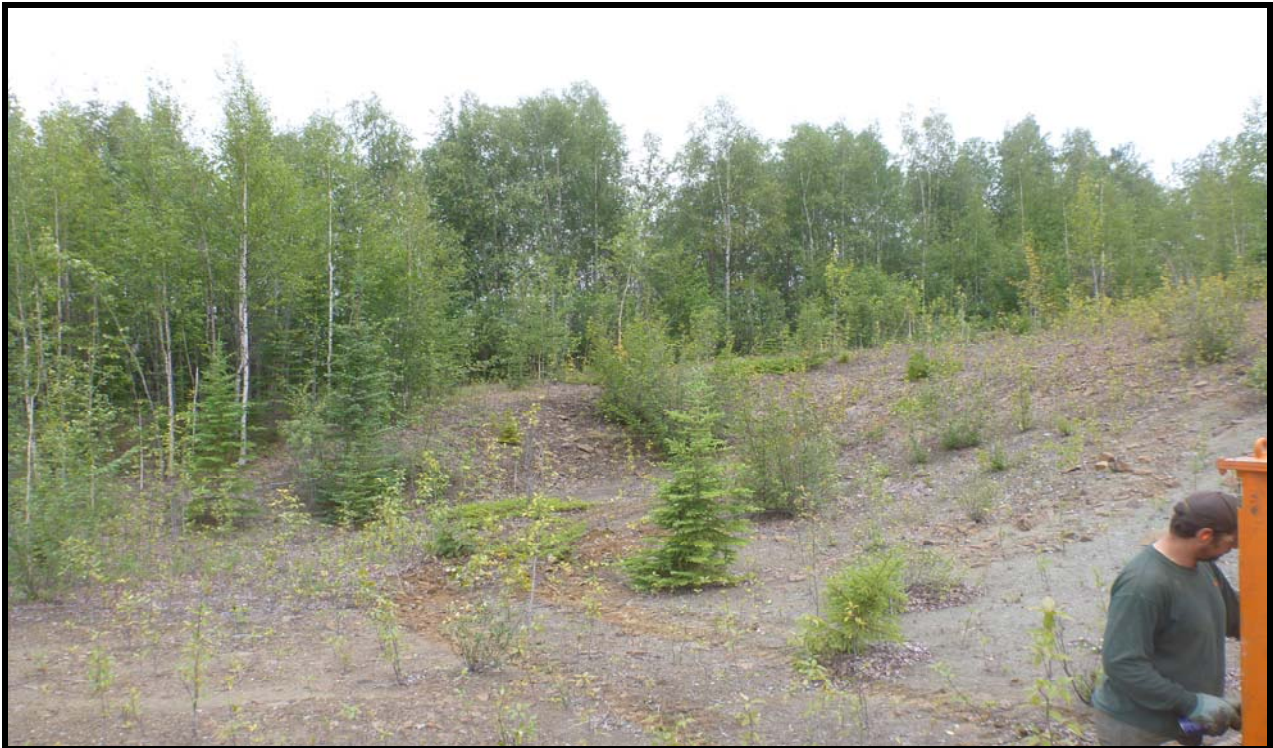
Figure 8: Proposed realignment near station 77+43. Photo is looking southwest at high ground composed mostly of highly weathered bedrock in a probable cut area. Photo is taken within a small material site excavation.

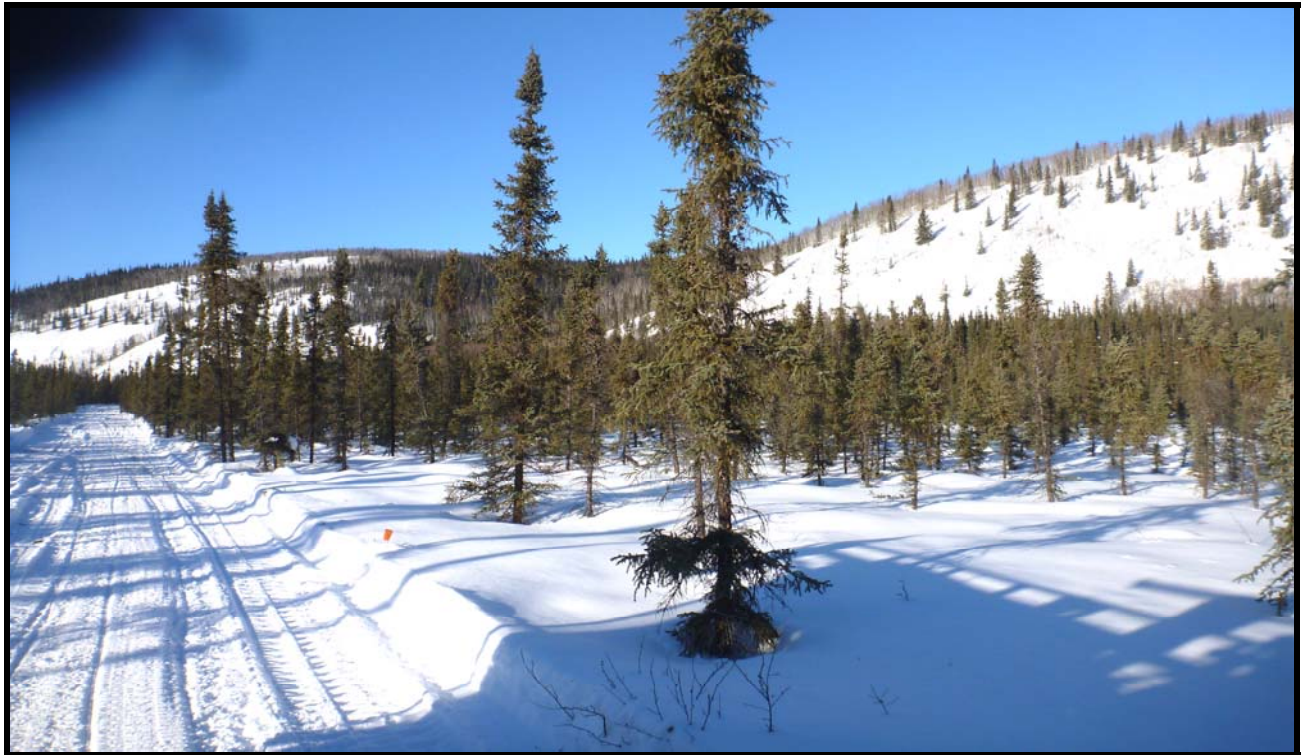
Figure 10: Proposed realignment near station 116+80. Photo is looking northwest at the alignment to the left of the photo and hills bounding the alignment to the north. Drilling indicated ice-rich subsurface soils in this area.

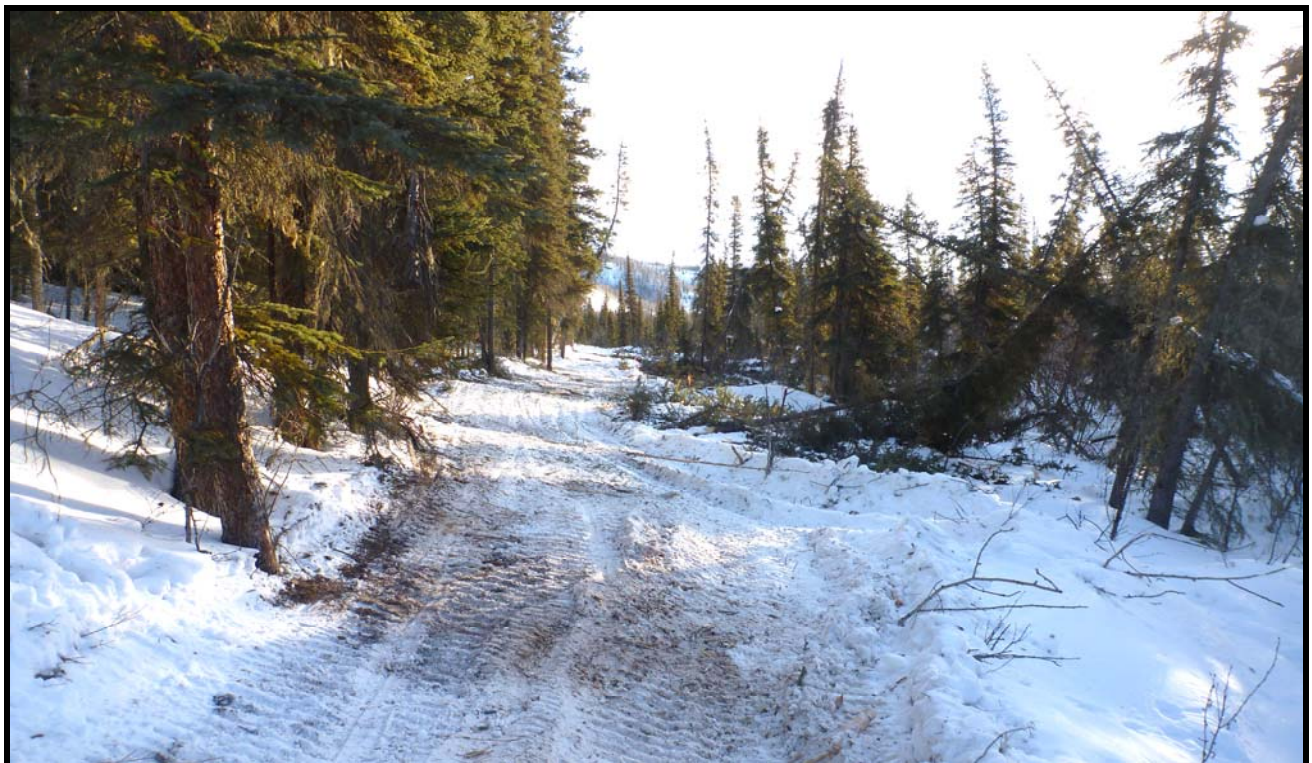
Figure 11: Proposed realignment near station 167+57. Photo is looking east with a hill slope to the left and low drainage area to the right. The hill slope could have unstable ice-rich silt material near the surface. Drilling indicated thawed soils underlying seasonally frozen soils in this area of the alignment.

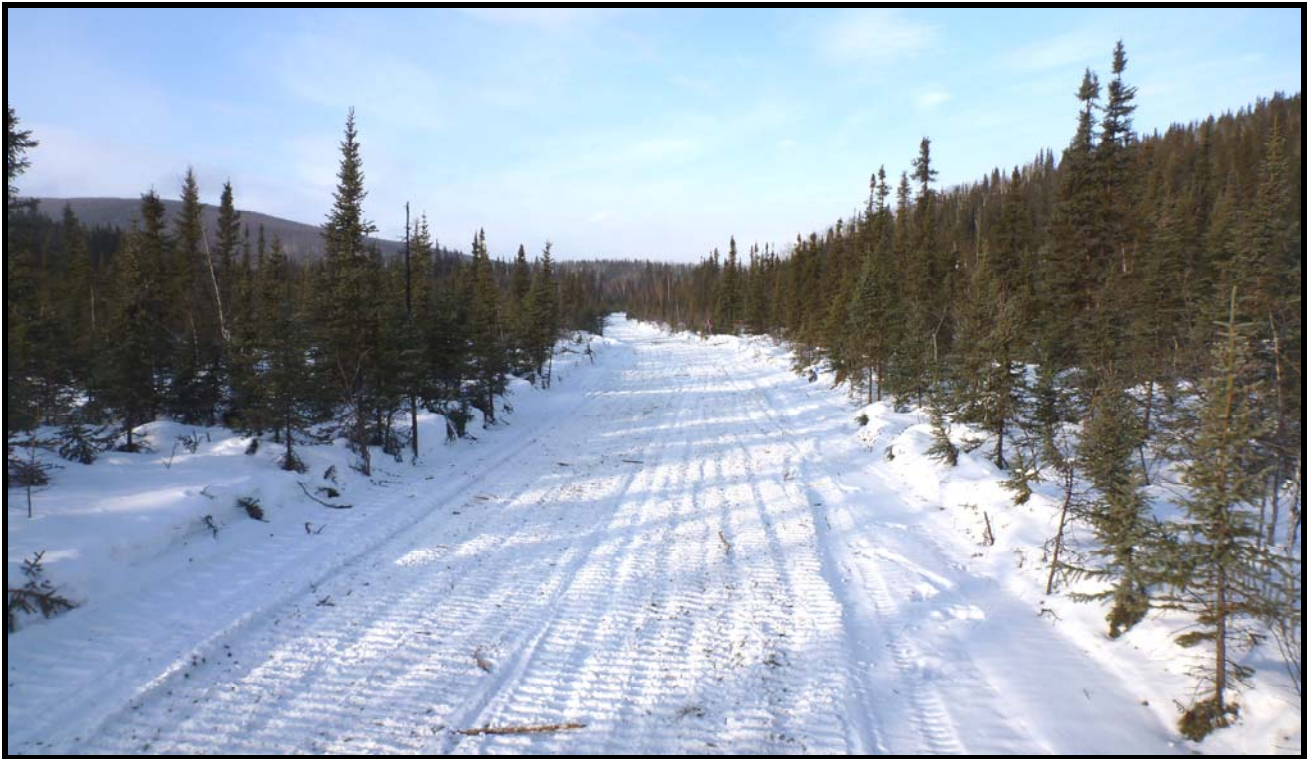
Figure 12: Proposed realignment near station 182+20. Photo is looking west. Drilling in this low lying area indicated ice-rich subsurface soils.

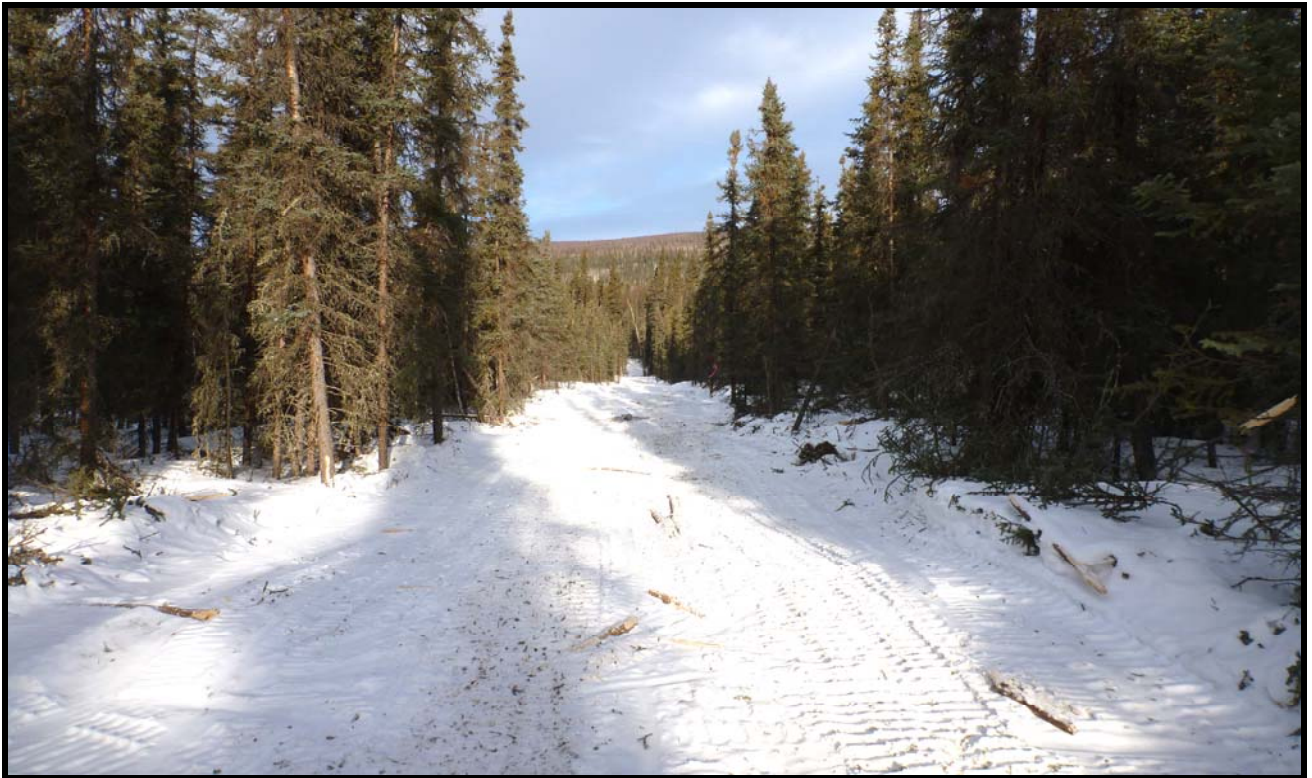
Figure 14: Proposed realignment near station 206+52. Photo is looking to the west and up a gradual slope toward a hill. Drilling in this area indicated ice-poor subsurface soils.

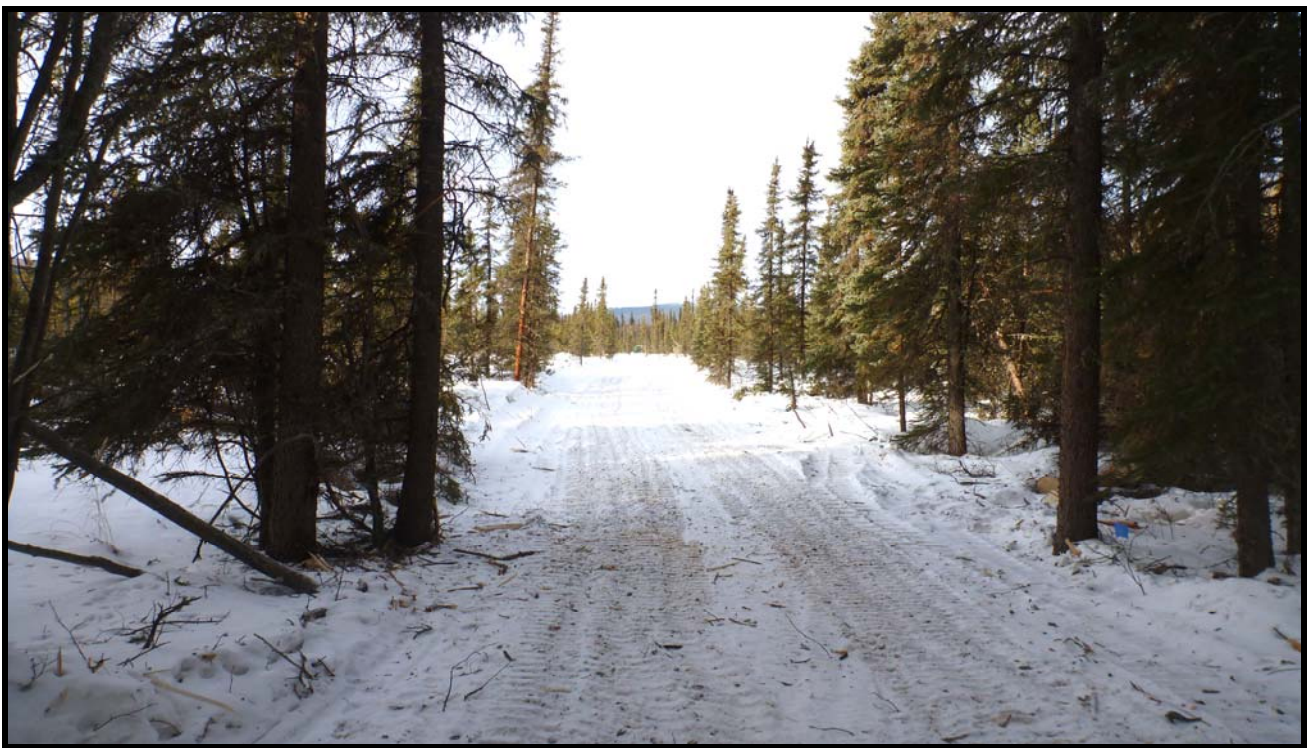
Figure 15: Proposed realignment near station 224+15. Photo is looking west at abrupt change from wooded hill slope area to flat low-lying open area. Drilling indicated wooded high ground areas generally consisted of ice-poor sand or silt, while flat low-lying open areas consisted of ice-rich soils.

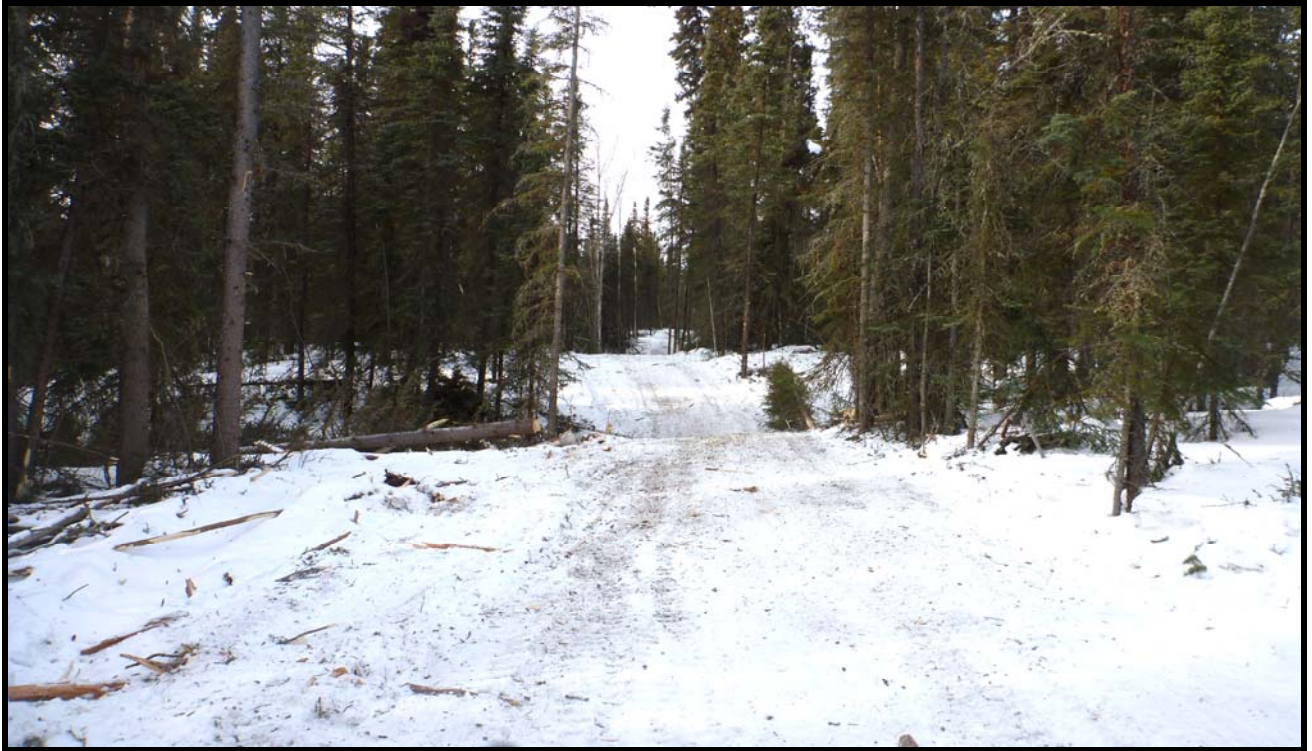
Figure 16: Proposed realignment near station 245+93. Photo is looking west at wooded hill area. Drilling in this area indicated frozen ice-poor sand or silt subsurface soil.

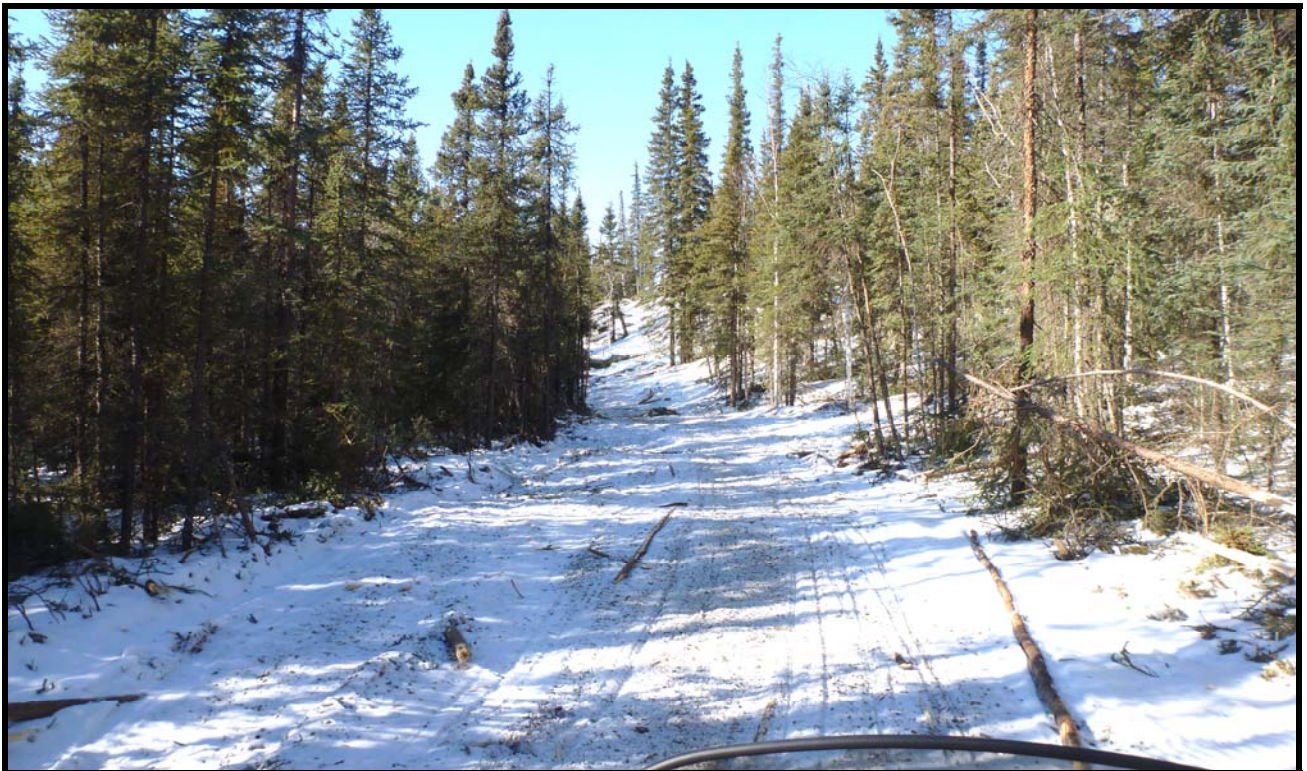
Figure 17: Proposed realignment near station 278+09. Photo is looking west at abrupt elevation change or bench located in the middle background. The change is also a transition between ice-rich and ice-poor surface soils.

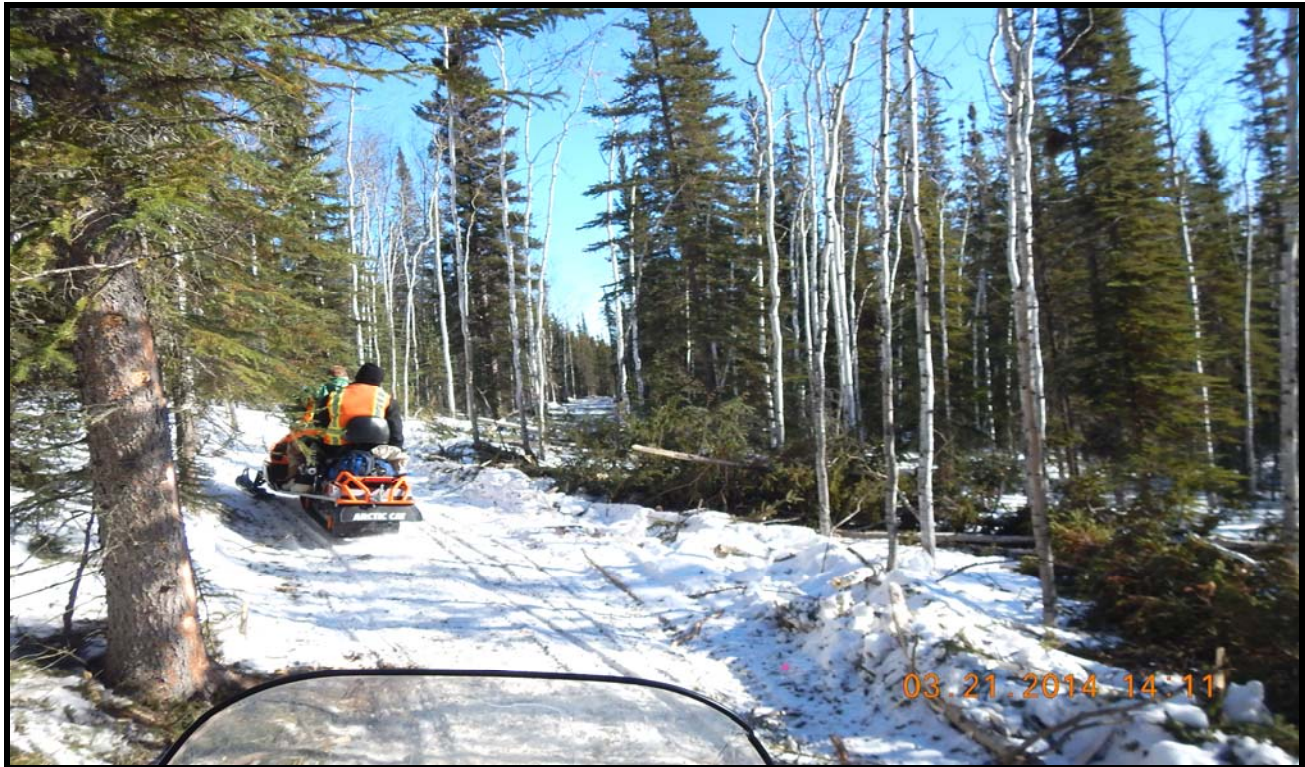
Figure 18: Proposed realignment near station 303+85. Photo is looking east. Drilling in the area indicated ice-poor sandy subsurface soil.

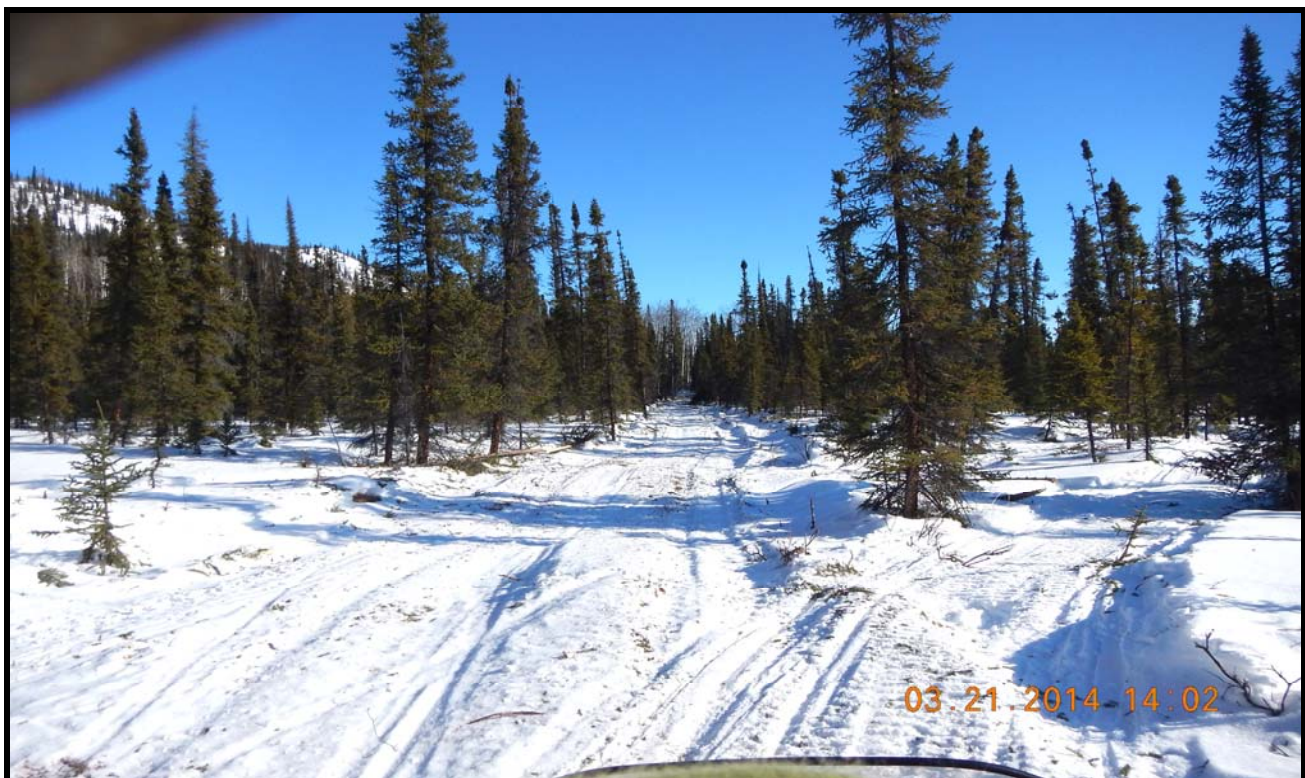
Figure 19: Proposed realignment near station 332+00. Photo is looking east at low-lying area just east of Lost Creek. Drilling in this area indicated ice-rich subsurface soils.

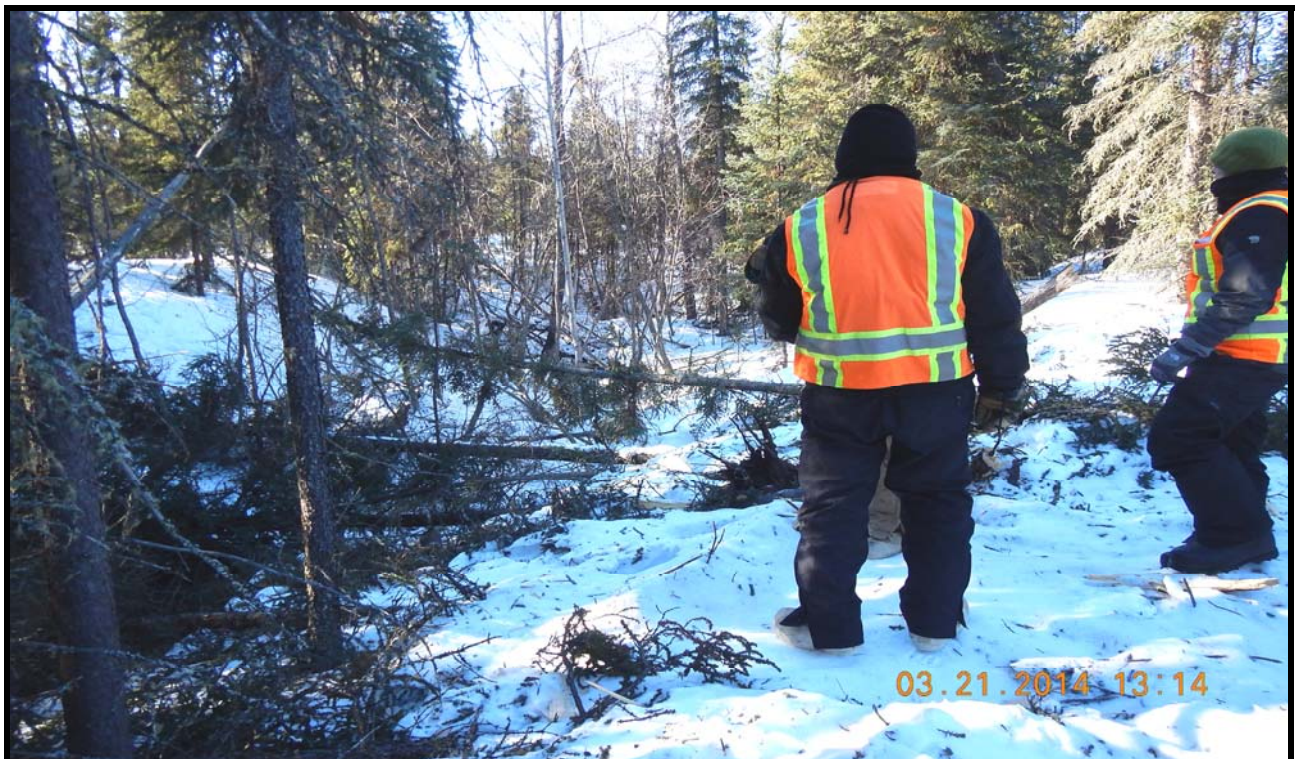
Figure 21: Proposed realignment near station 358+00. Photo is looking west at an unnamed creek. The creek has a narrow thaw bulb and is deeply incised into silty soils at approximately 6- to 8-foot depth.

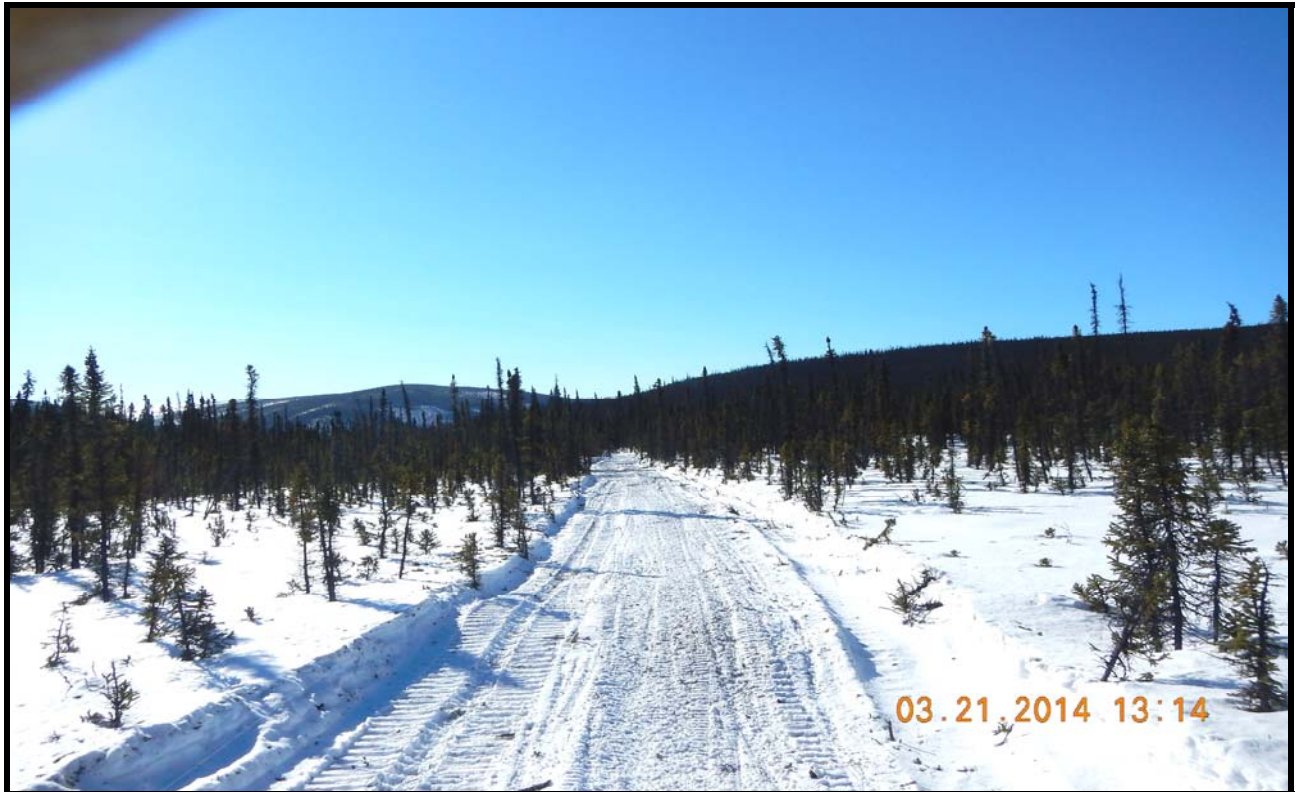
Figure 22: Proposed realignment near station 378+80. Photo is looking south. Drilling in this area indicated highly ice-rich subsurface silt soil.

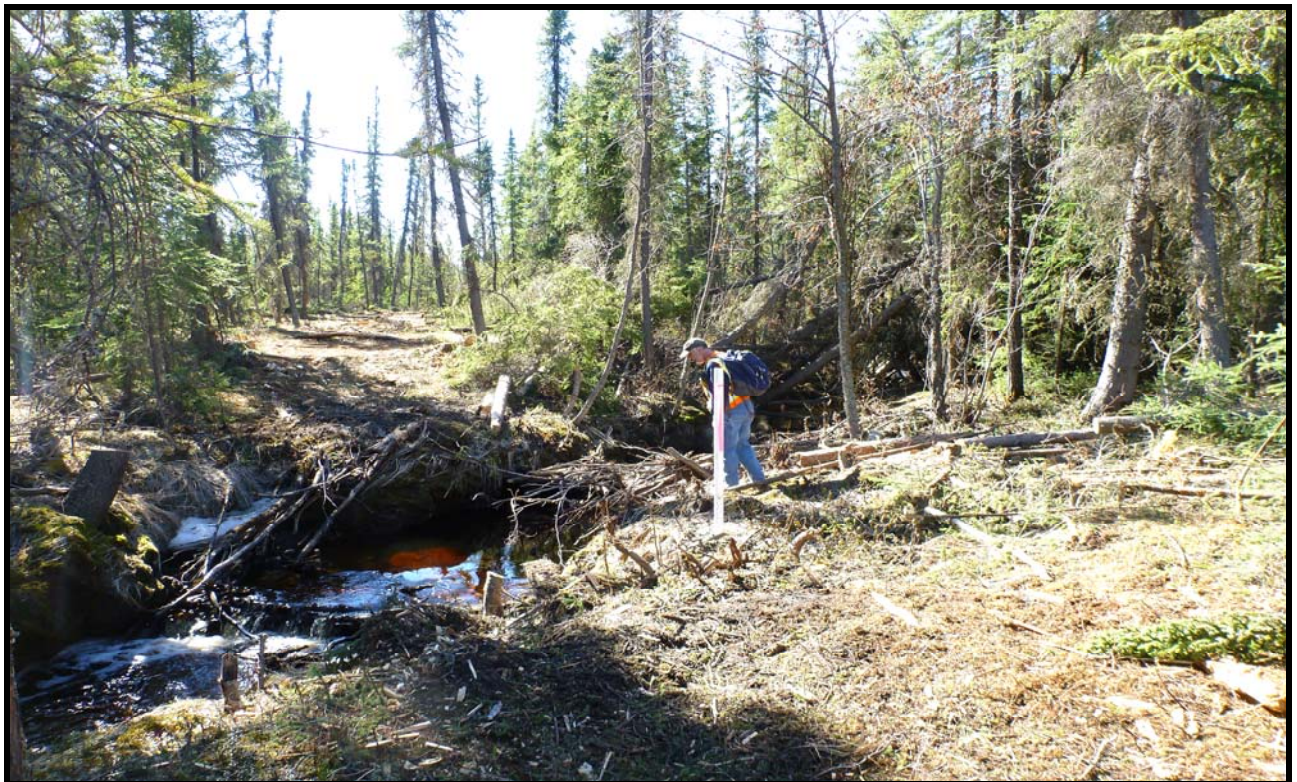
Figure 23: Proposed realignment near station 406+65. Photo is looking south at 2nd unnamed creek. This second creek is smaller and not as deeply incised as the previous creek crossing.

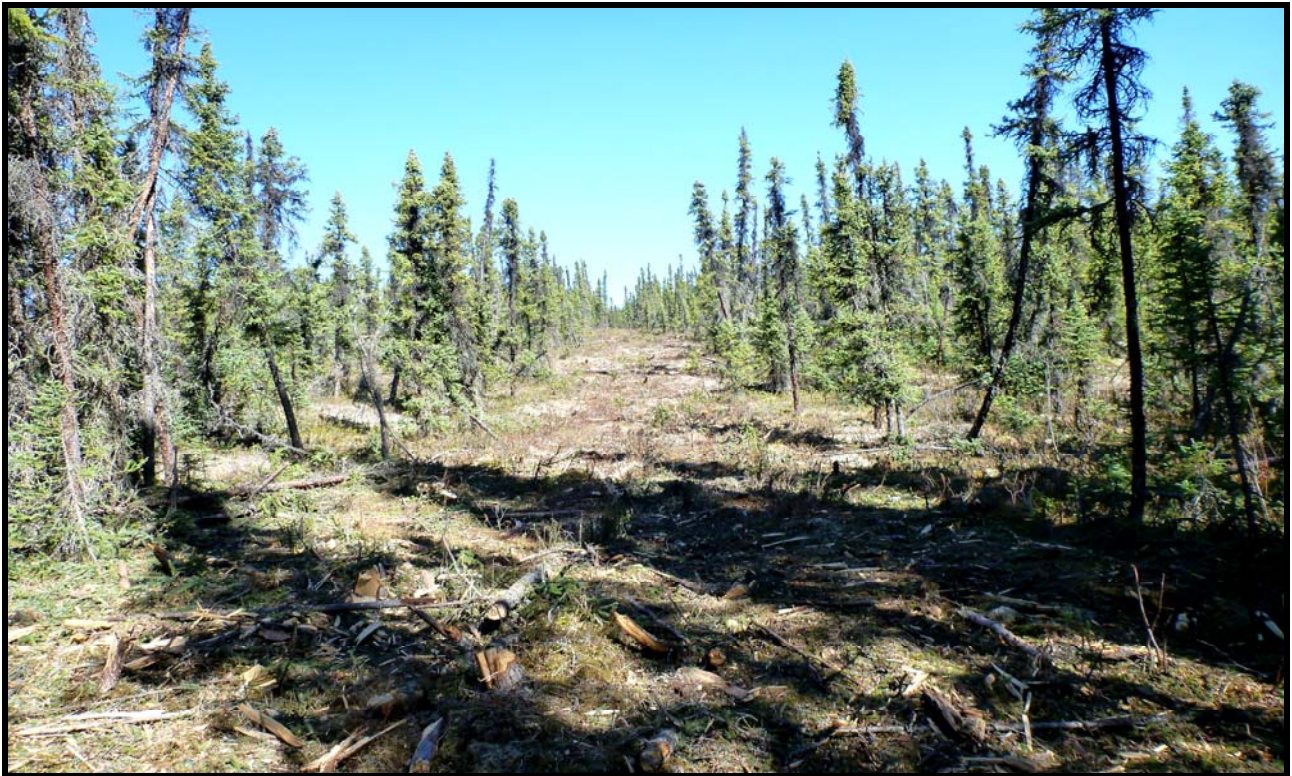
Figure 24: Proposed realignment near station 412+16. Photo is looking north. Drilling in this area indicated ice-rich silt. The test hole just south of this location encountered an ice wedge.

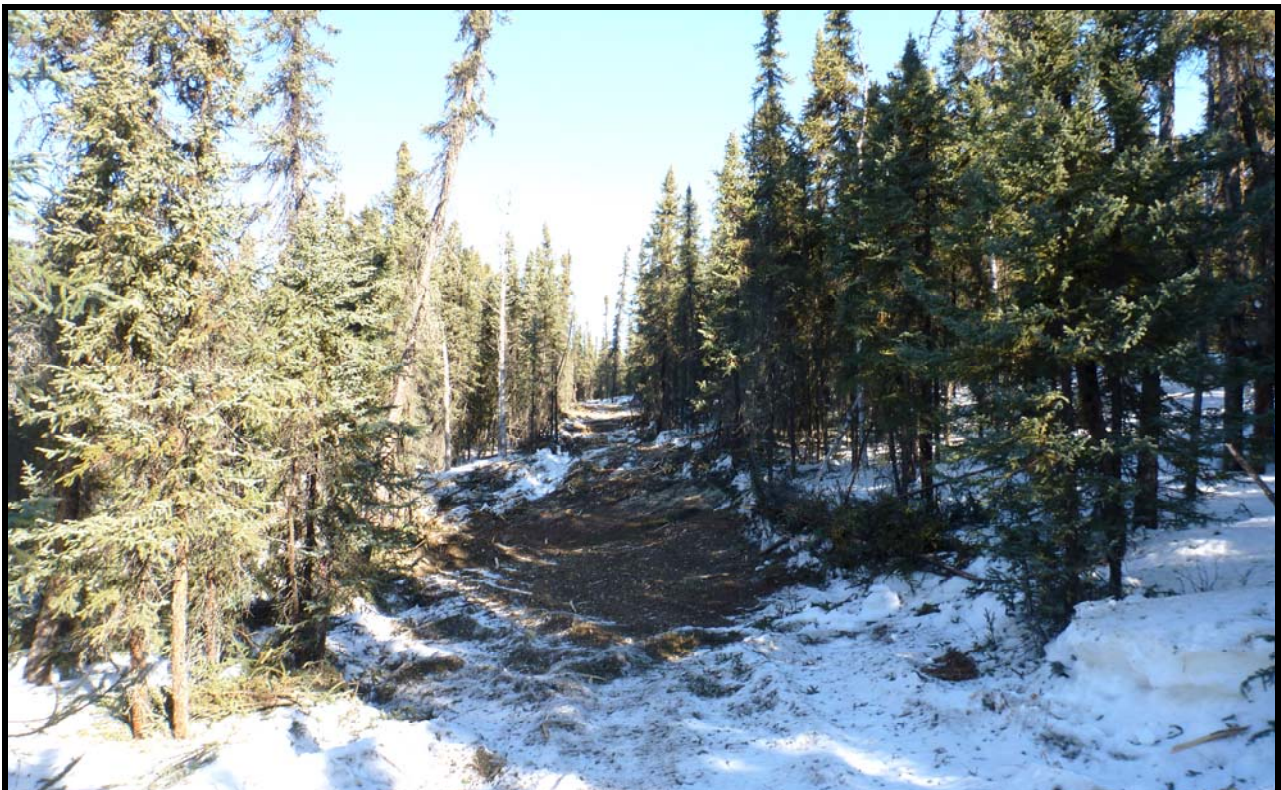
Figure 25: Proposed realignment near station 429+19. Photo is looking north. Drilling encountered ice-rich silt, while two test holes drilled just to the south encountered ice-poor sand.

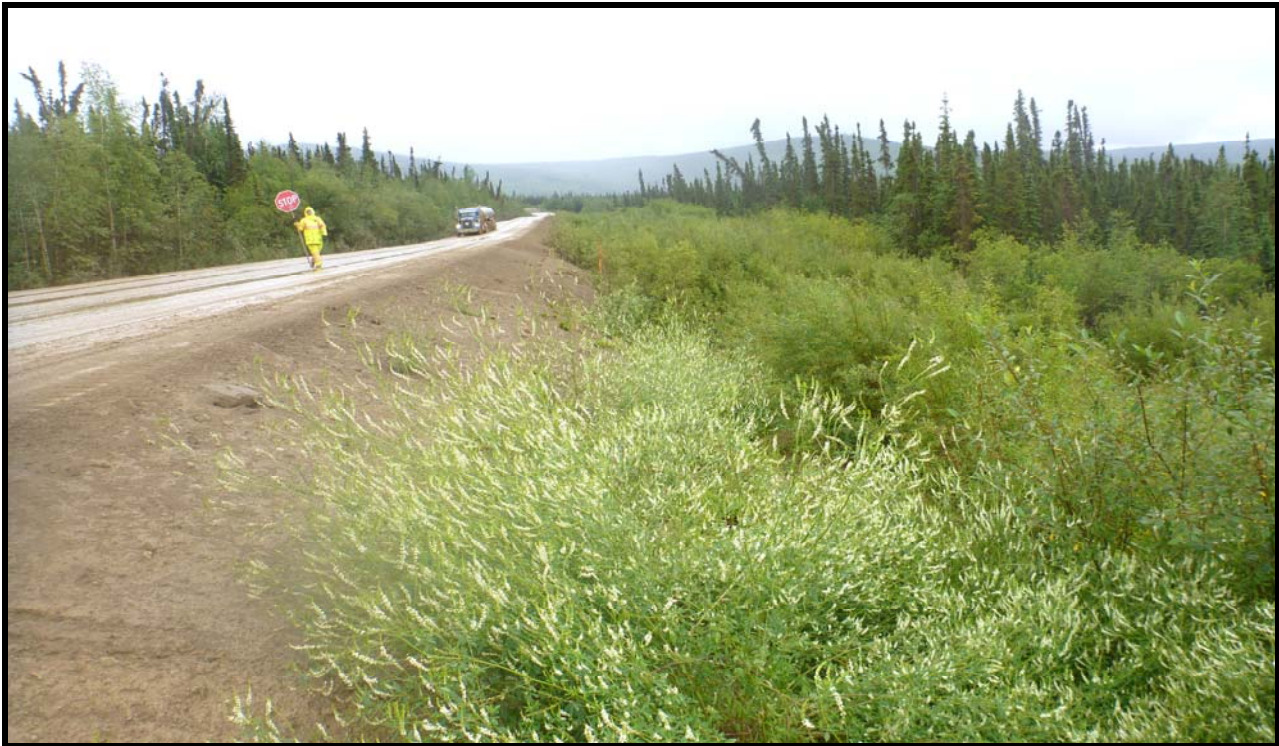
Figure 26: Existing Dalton Highway near station 458+50. Photo is looking southeast. The road has deep fills on the right and minor cut or fills on the left side. The ditch on the right is uneven ground with ponded water in some areas and drunken trees near those areas.
