MEMORANDUM

State of Alaska
Department of Transportation & Public Facilities
Northern Region Preconstruction

SUBJECT: Dalton Highway MP 0 to 9
Realignment Project.
Preliminary Geotechnical
Investigation Memo
AKSAS 60911

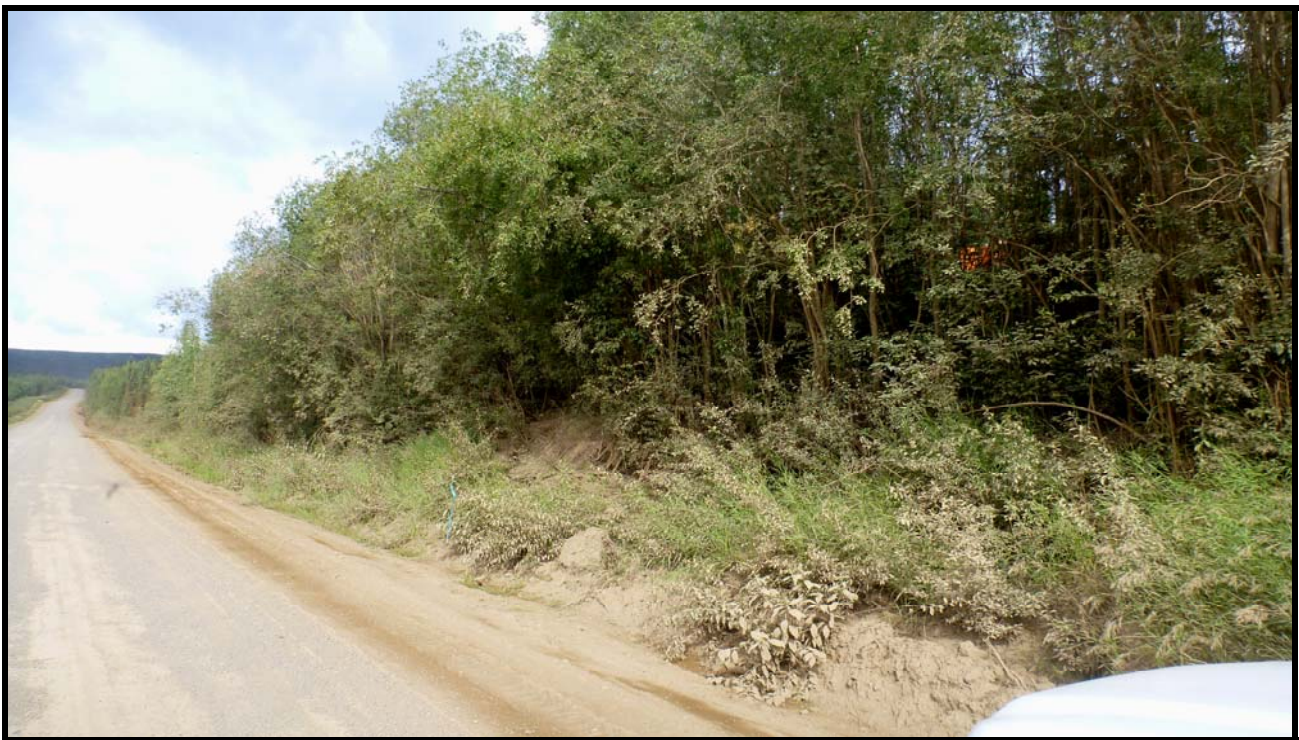
Figure 27: Existing Dalton Highway near station 467+00. Photo is looking northwest at north side ditch and side slopes at 7- to 10-feet higher in elevation than the road elevation. Drilling in the ditch at this location encountered highly ice-rich silts to 25-foot depth, indicating road widening in this area will cut into ice-rich side slopes.

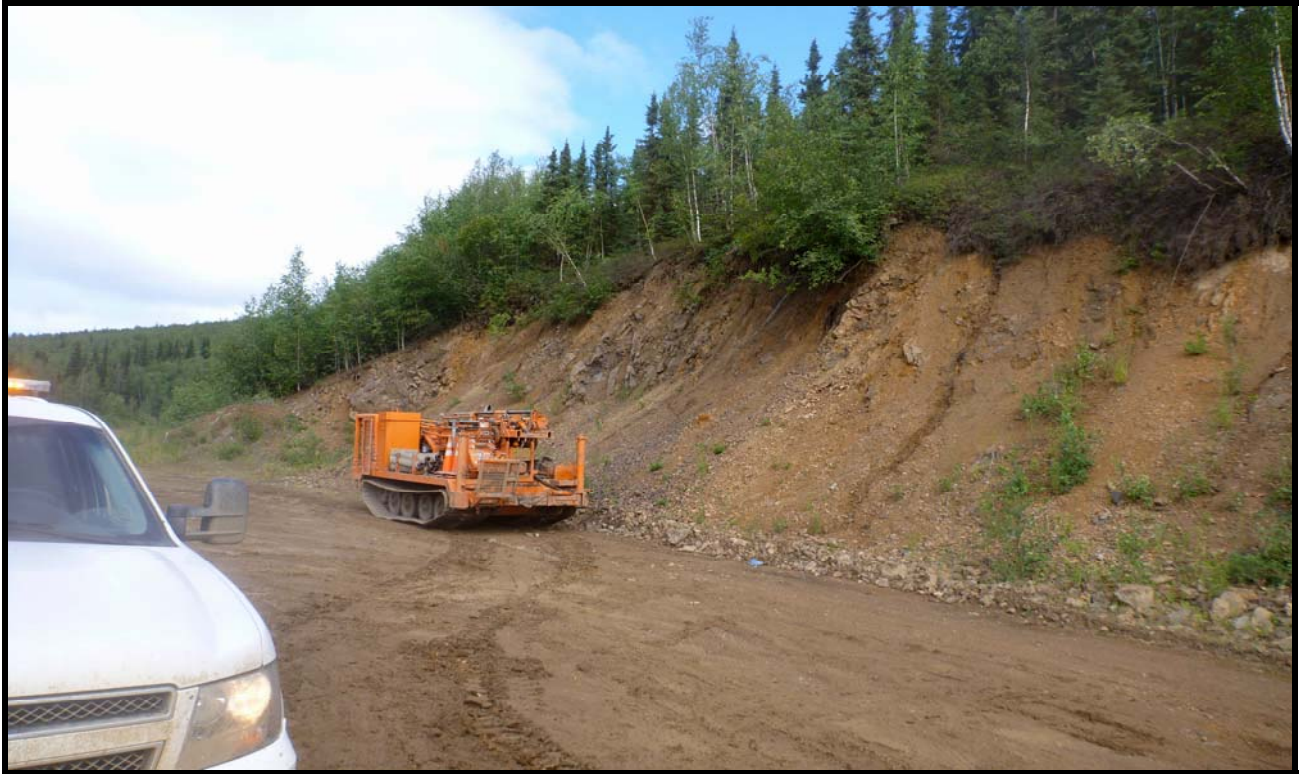
Figure 28: Existing Dalton Highway near station 510+00. Photo is looking north at east ditch with a highly weathered bedrock slope at the vehicle pullout.

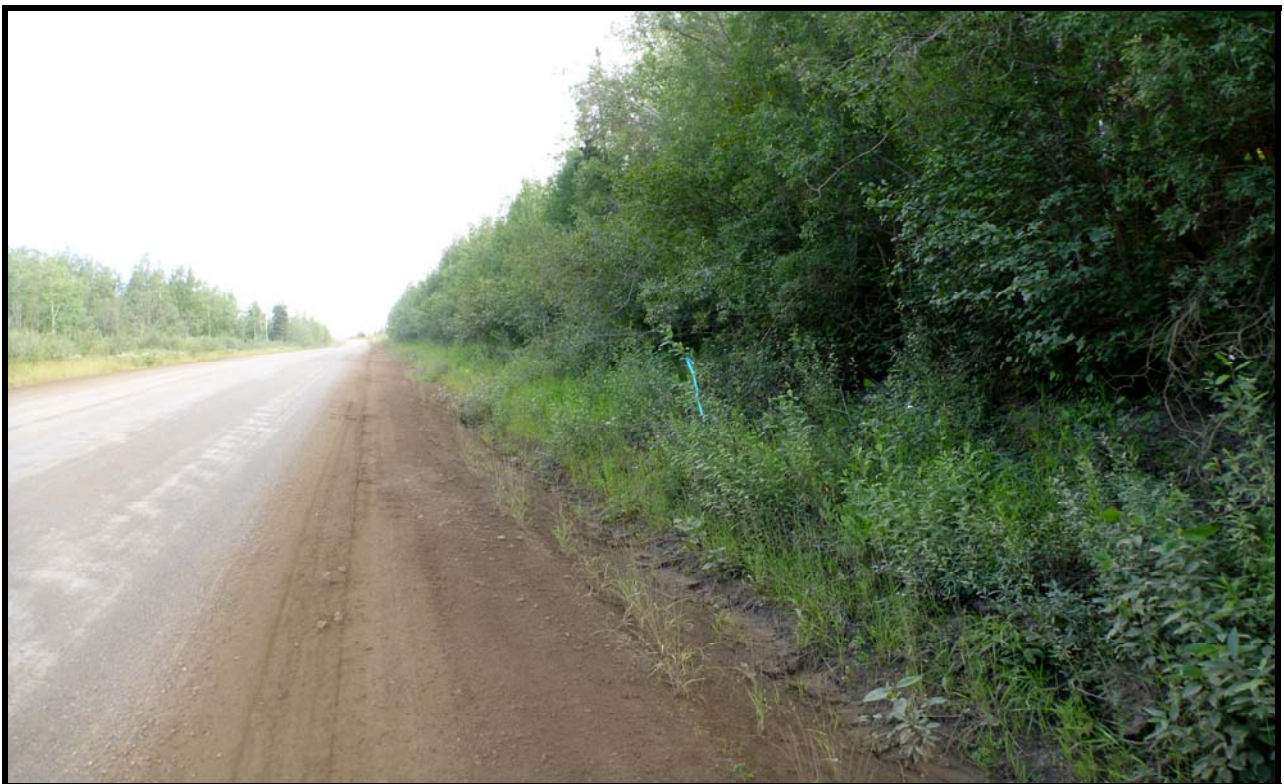
Figure 29: Existing Dalton Highway near station 537+00. Photo is looking to the north at east ditch side slopes. Test holes drilled on the slope encountered shallow thawed highly weathered bedrock.

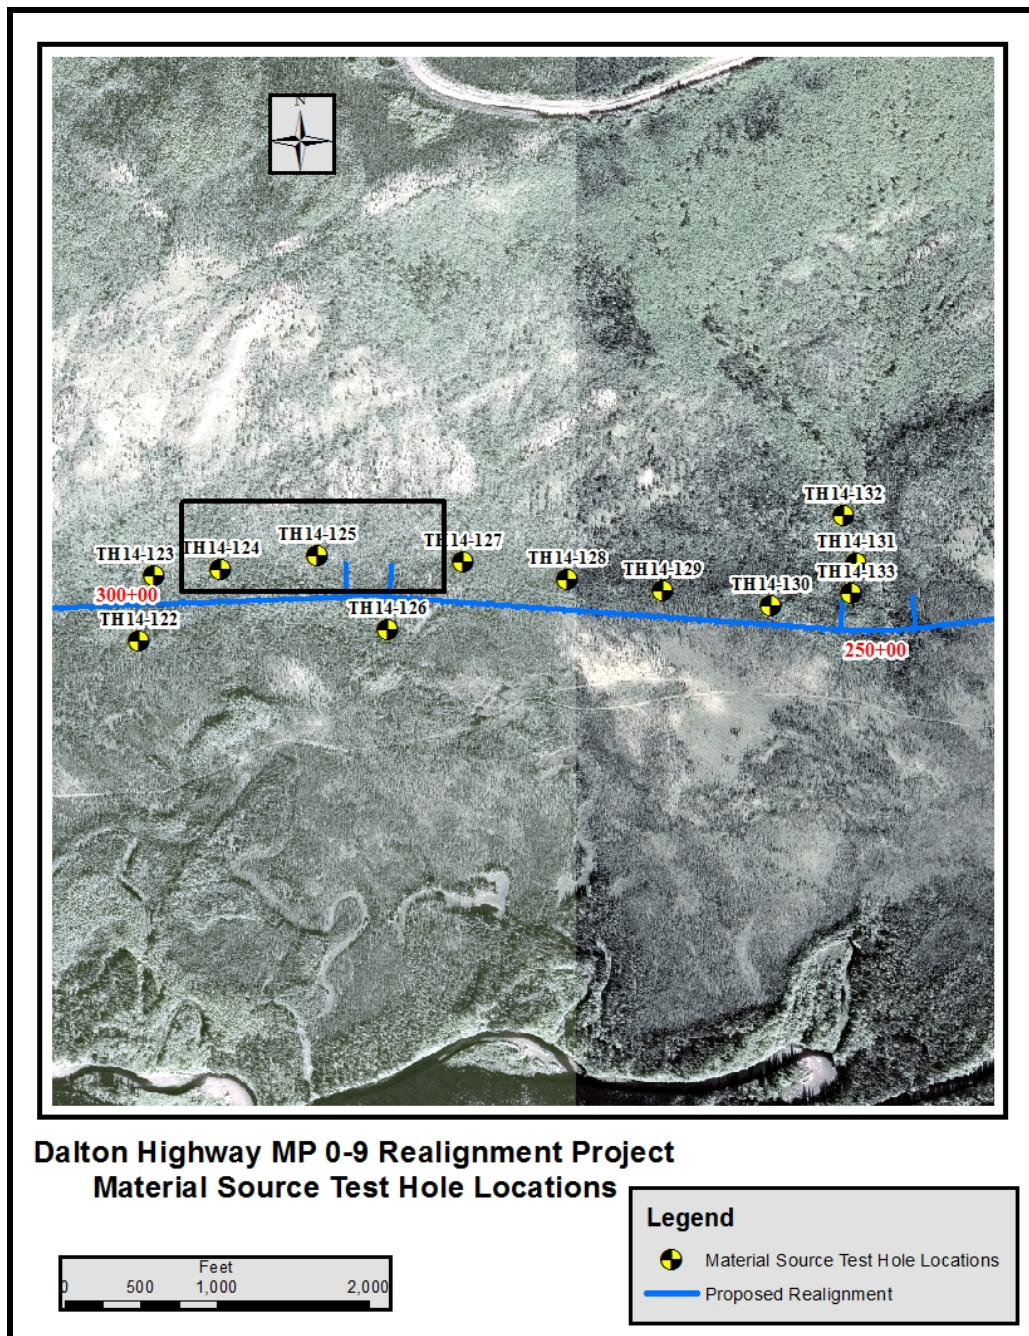
Figure 30: Dalton Highway Realignment Project MP 0 to 9. Potential material source test hole locations. The outlined rectangle is approximately 1,700-feet in length by 600-feet wide. Test holes drilled in the area encountered approximately 20-feet of sand with gravel. This rectangle area encompass 750,000 cubic yards of potential borrow material.

This exploration program resulted in the following, two test holes drilled south of the alignment (TH14-122 and TH14-126), encountered sand with gravel from 1-to 8-feet and 8.5-to 13-feet depth respectively. The four test holes drilled north of the alignment (TH14-123, TH14-124, TH14-125 and TH14-127), encountered significantly more potential borrow material than those test holes drilled south of the alignment. Laboratory testing indicated the material was generally classified as silty sand with gravel, with quality related testing of: LA abrasion loss 24, degradation value 67, and sodium sulfate soundness at 14.2 for the course fraction and 15.1 for fine fraction. These results meet standard specifications for Select Material Type C.

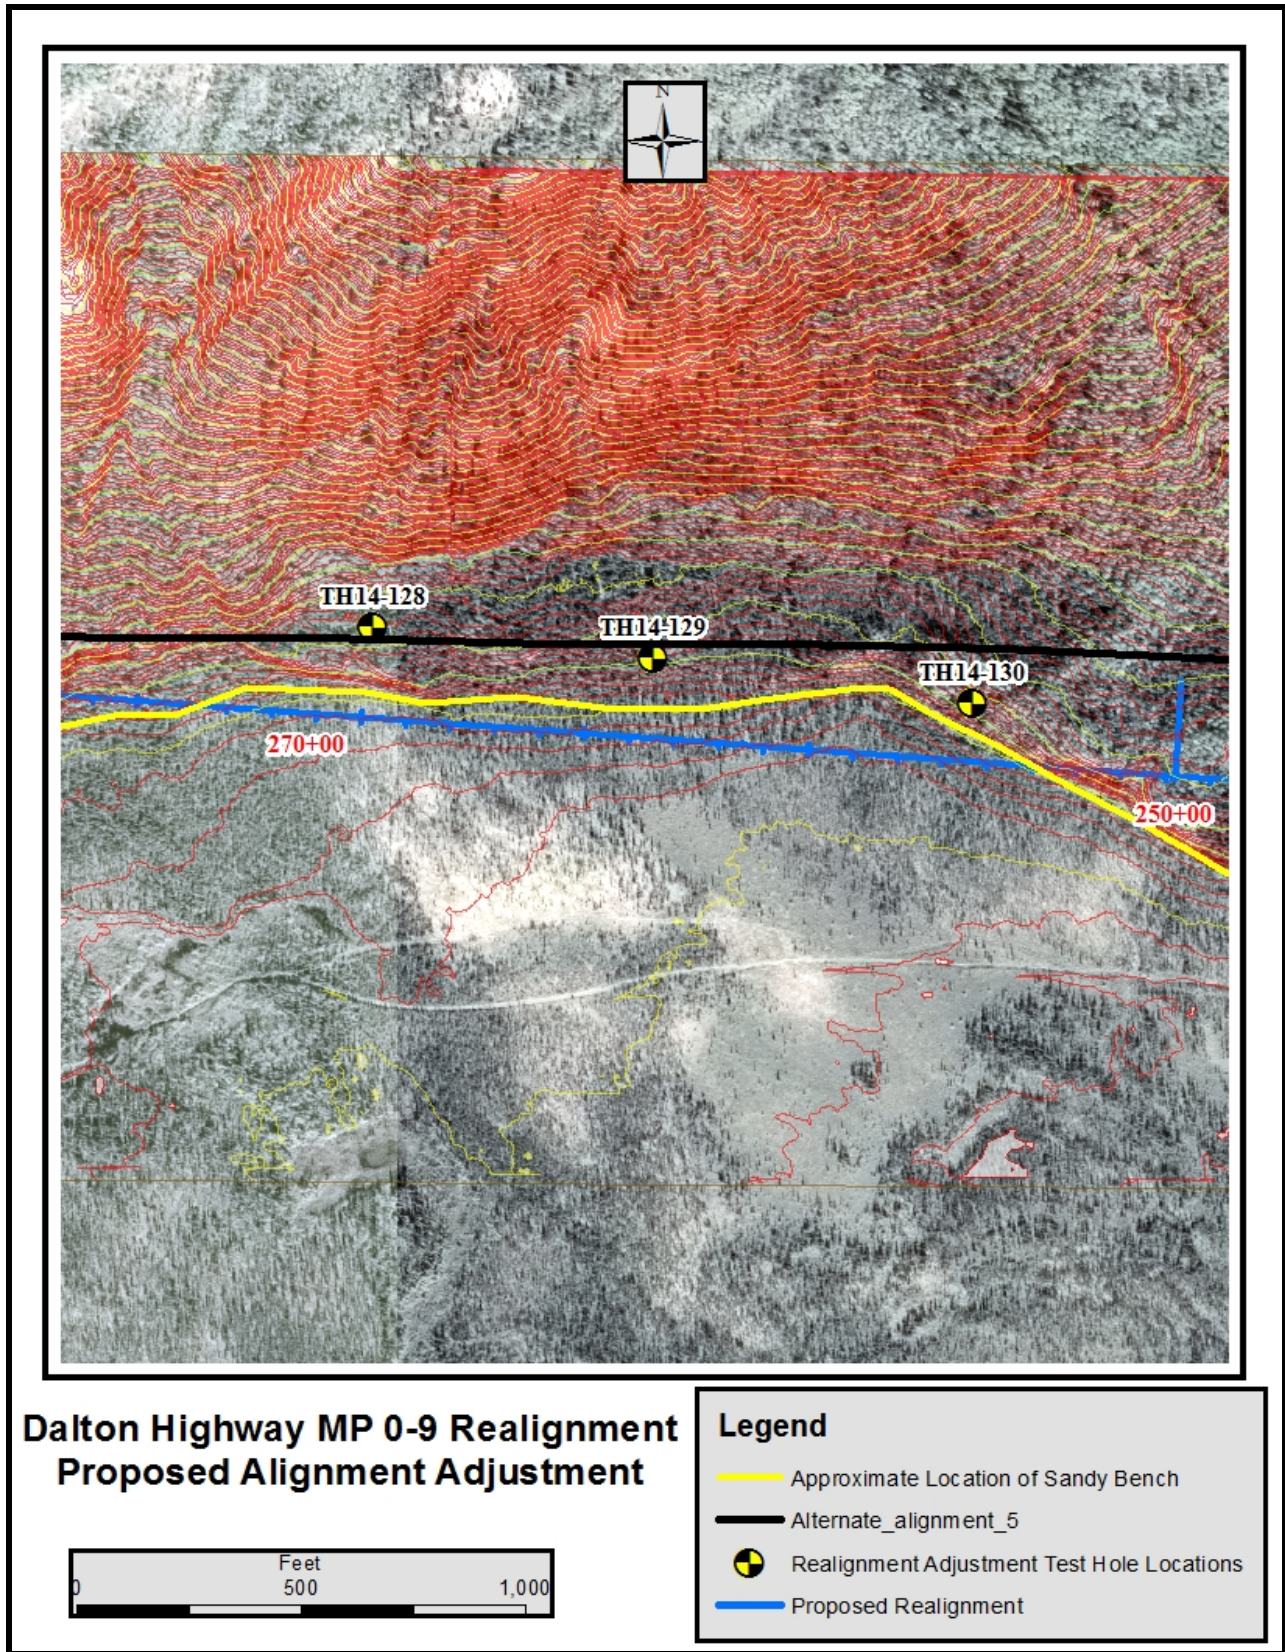
During exploration drilling of the proposed realignment, a suspected sand or gravel bench with an abrupt elevation change of approximately 8-feet was observed just north of the proposed realignment centerline at approximately station 250+00 to 275+00 (Figure 31). Three test holes (TH14-128 to TH14-130) previously drilled for a potential material source also served to explore the “bench”. Drilling on the bench confirmed sand and gravel material in the subsurface, and indicates “the bench” as outlined below in Figure 31 is a better alternative to the original realignment in order to avoid ice-rich silt foundation material.

Figure 31: Dalton Highway Realignment Project MP 0 to 9. Realignment adjustment test hole locations. Yellow line represents the approximate location of the observed “bench”.

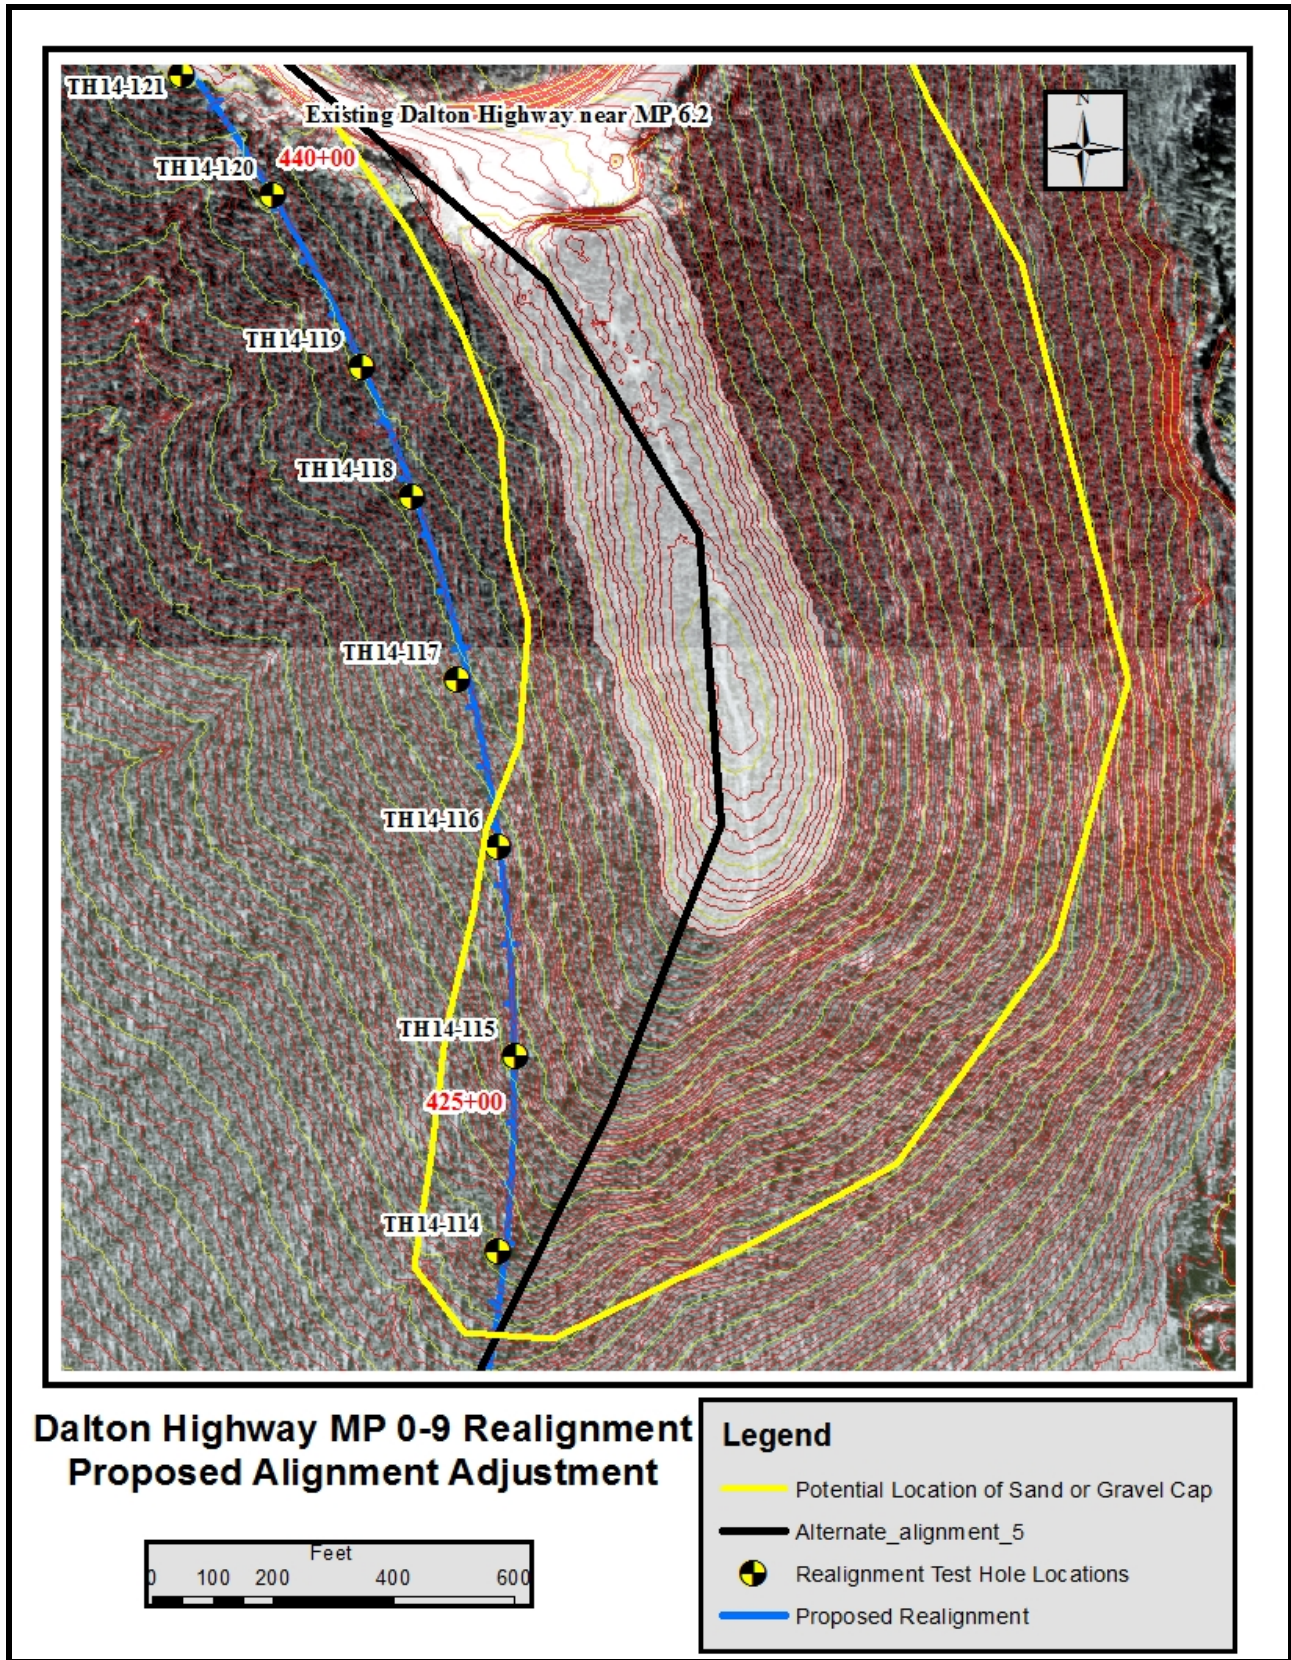
A second potential realignment adjustment was observed on the hill leading to the existing Dalton Highway near MP 6.2 (Figure 32). The original proposed realignment runs along the north side of the hill from approximately station 420+00 to 440+00. Test holes drilled in the area generally encountered ice-rich silt foundation material except at three hole locations.

Figure 32: Dalton Highway Realignment Project MP 0 to 9, second proposed realignment adjustment. Yellow area represents the approximate location of a potential sand or gravel cap to the hill, including the three test hole locations that encountered the material.

These three test holes (TH14-114 to TH14-116) encountered sand and gravel to depths explored, and gravel material was observed in small excavations at the top of the hill. From these observations we propose a second adjustment to the original realignment.

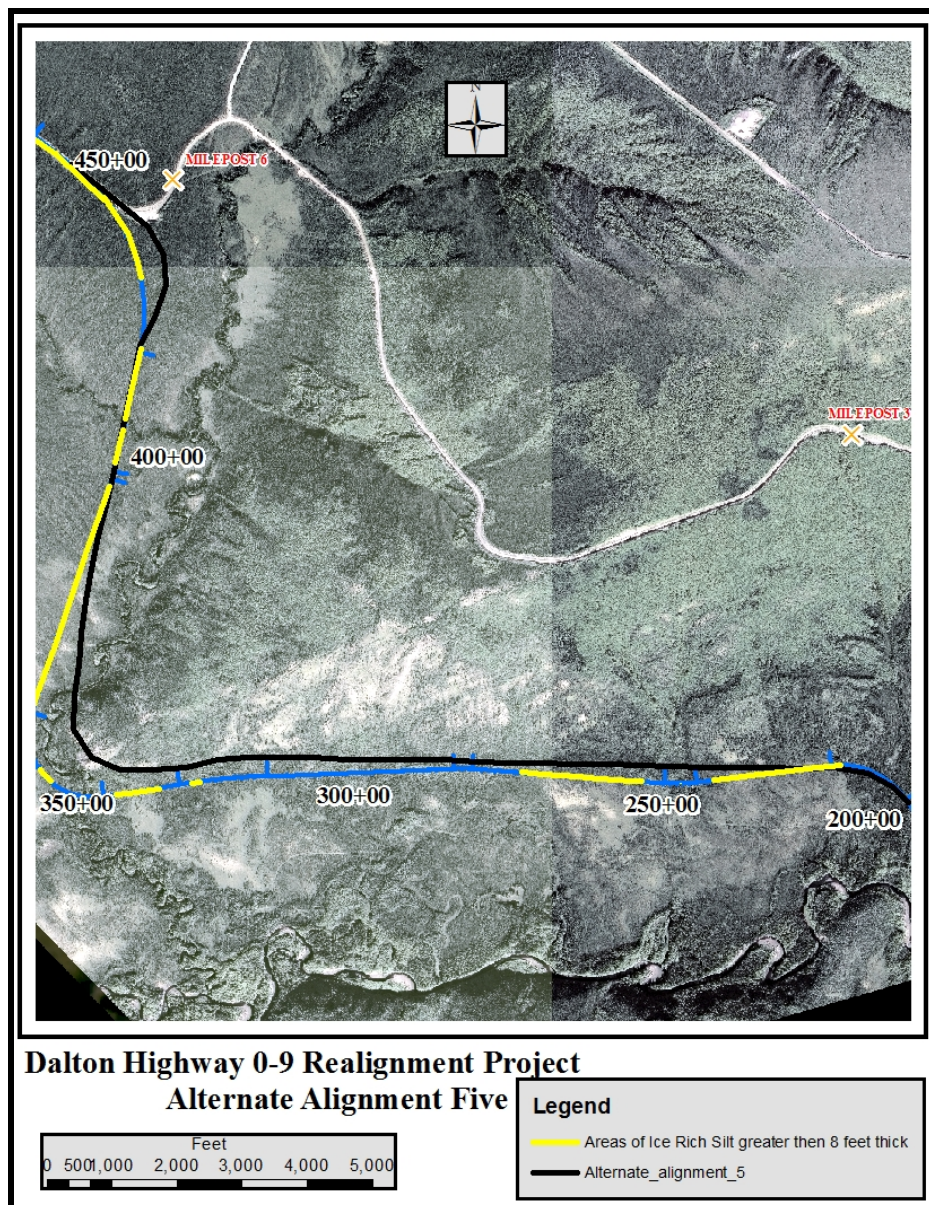
Figure 33: Dalton Highway Realignment Project MP 0 to 9. Proposed adjustment to original realignment, black line is preferred Alternate Alignment Five.
