MEMORANDUM

State of Alaska
Department of Transportation & Public Facilities
Northern Region Preconstruction

SUBJECT: Dalton Highway MP 0 to 9
Realignment Project.
Preliminary Geotechnical
Investigation Memo
AKSAS 60911

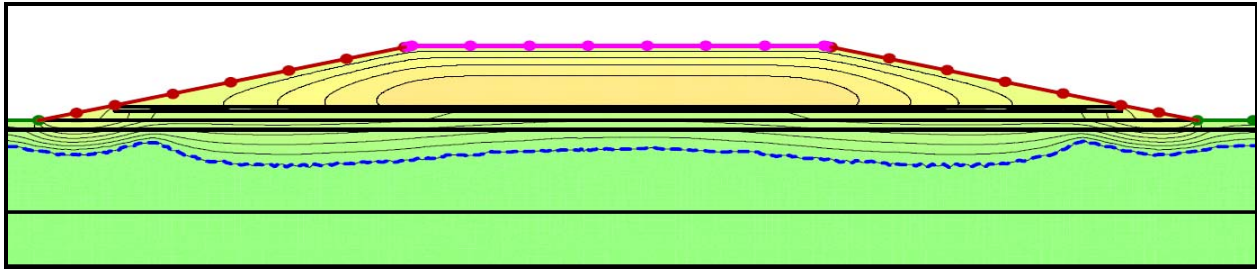
The model results indicate the typical active layer thickness in the project area is approximately 2.4-feet. This corresponds well to the typical active layer thicknesses from test holes drilled in undisturbed areas over ice-rich soils. The active layer was estimated to increase to 2.8-feet in depth for the 2050 temperature projections. Model results are shown below in Figures 5 and 6.

Figure 6: Eight foot embankment with 6-inches of insulation board under projected 2050 temperatures. Maximum depth of thaw occurs approximately during the last week in September. Dashed blue line is the 32 degrees Fahrenheit isotherm.

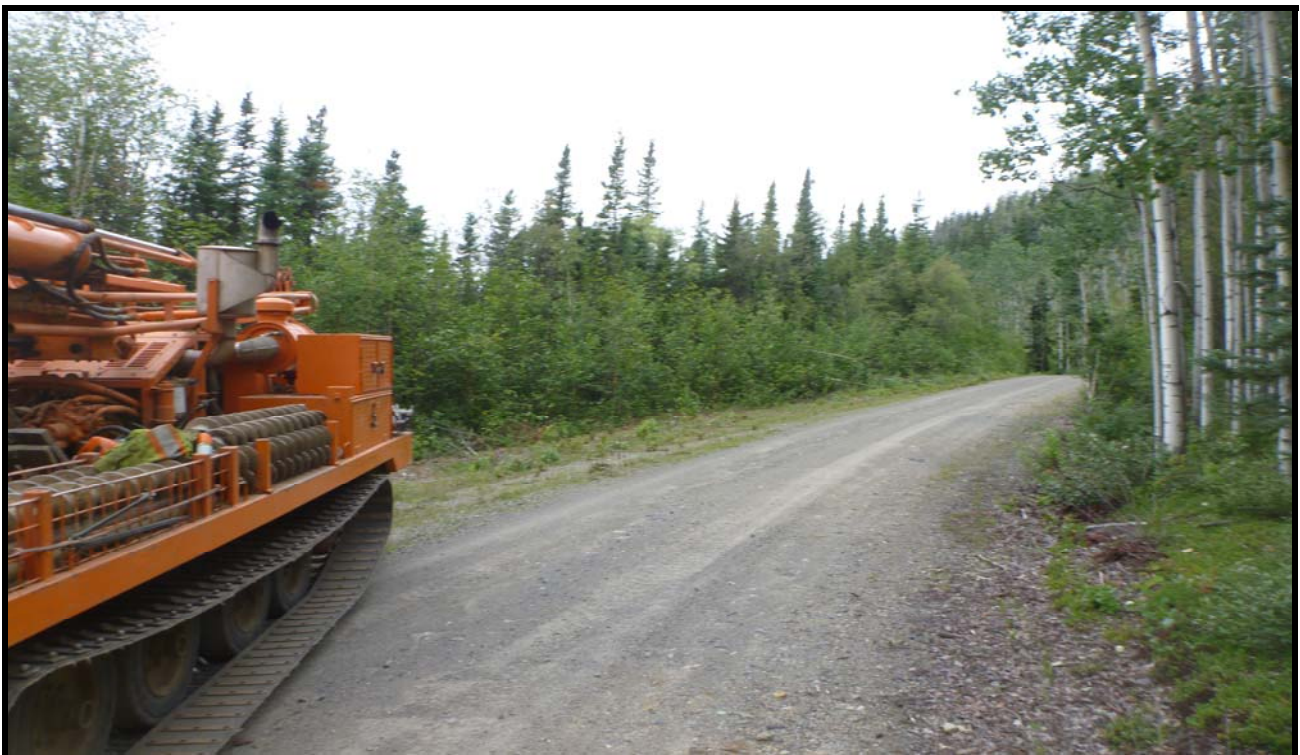
Figure 9: Proposed realignment near station 81+90. Photo is looking west along existing small access road. The access road starts at the Elliott Highway and travels west approximately 1-mile before come to a dead end.

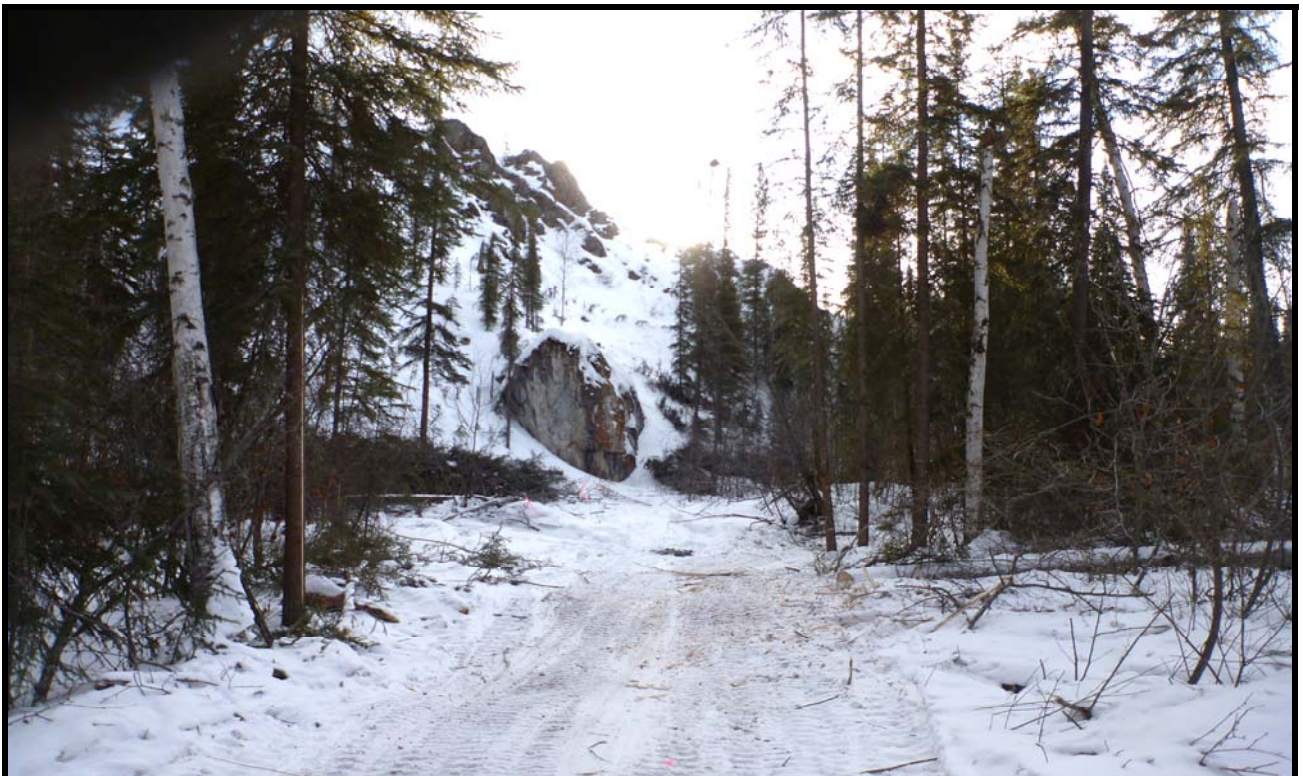
Figure 13: Proposed realignment near station 194+66. Photo is looking east at the east-ridge bedrock outcropping.

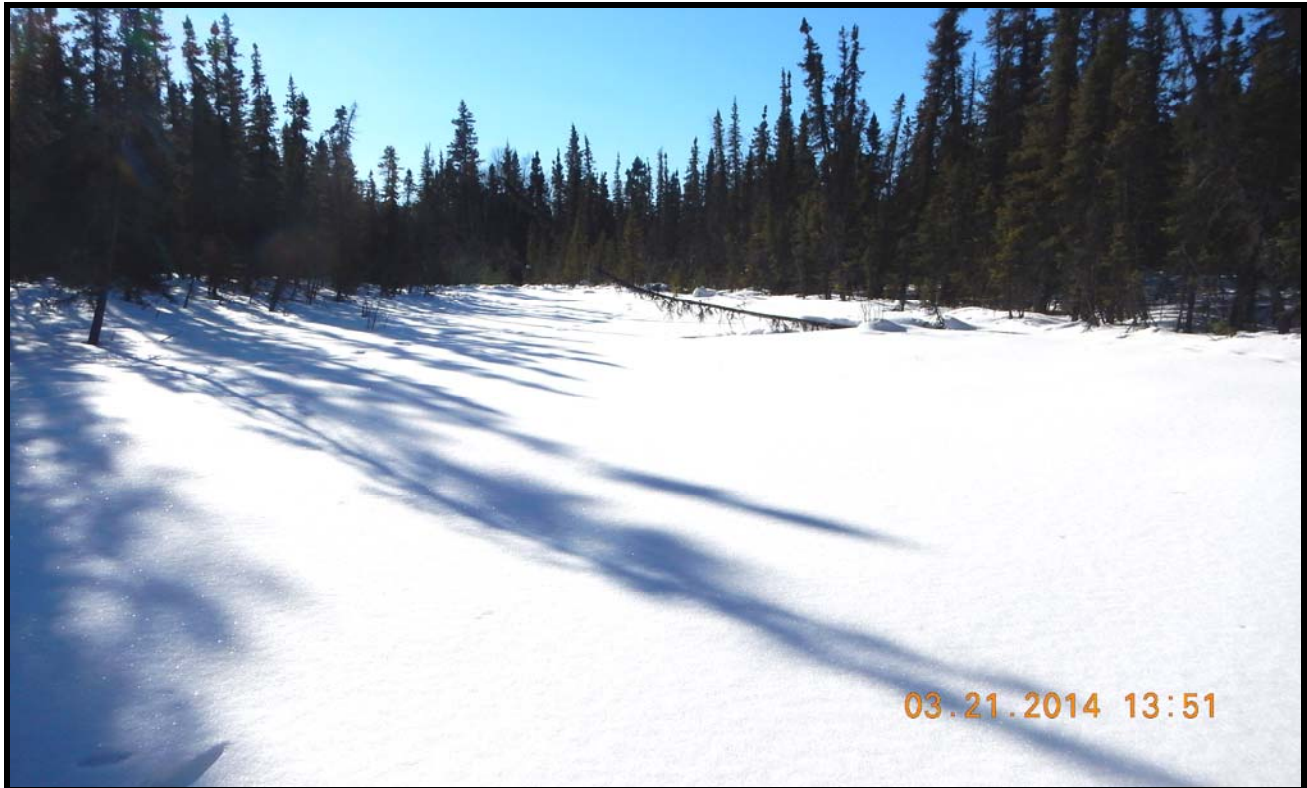
Figure 20: Proposed realignment near station 340+00. Photo is looking west at an oxbow branch of Lost Creek, just north of the originally planned alignment crossing at Lost Creek.
